Inspection and Assessment of Masonry Arch Bridges: Ivanjica Case Study

Citation: Sokolović, N.M.; Petrović, M.; Kontić, A.; Koprivica, S.; Šekularac, N. Inspection and Assessment of Masonry Arch Bridges: Ivanjica Case Study. *Sustainability* **2021**, *13*, 13363. <https://doi.org/10.3390/su132313363>

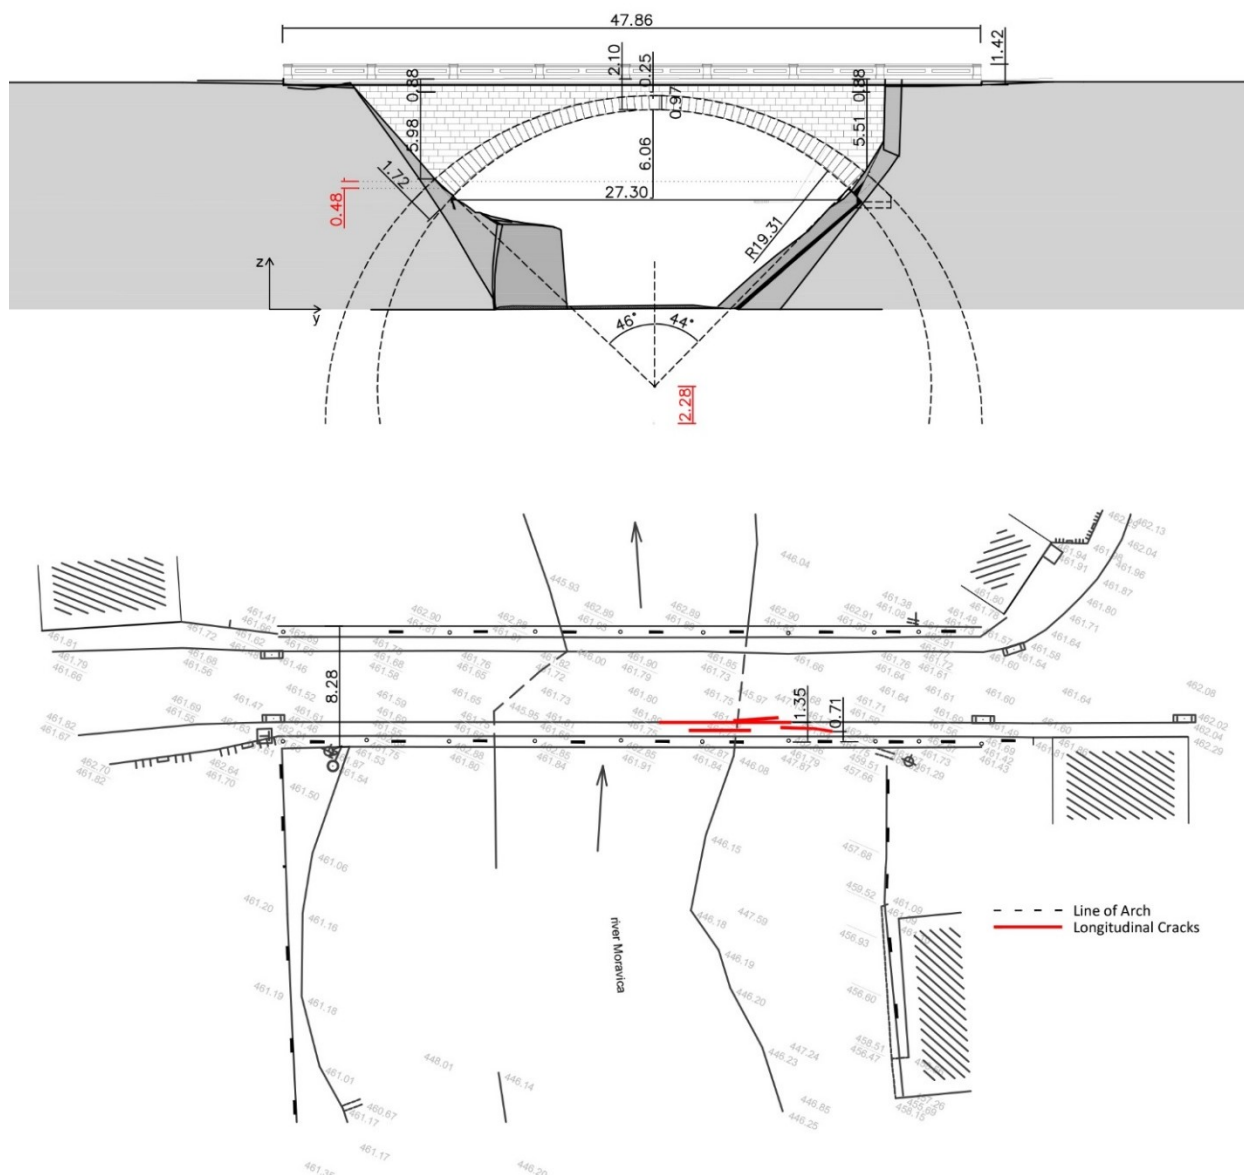
Figure 4. Geometric characteristics of the bridge: span, depth and arch rise, with highlighted position of developed longitudinal cracks.

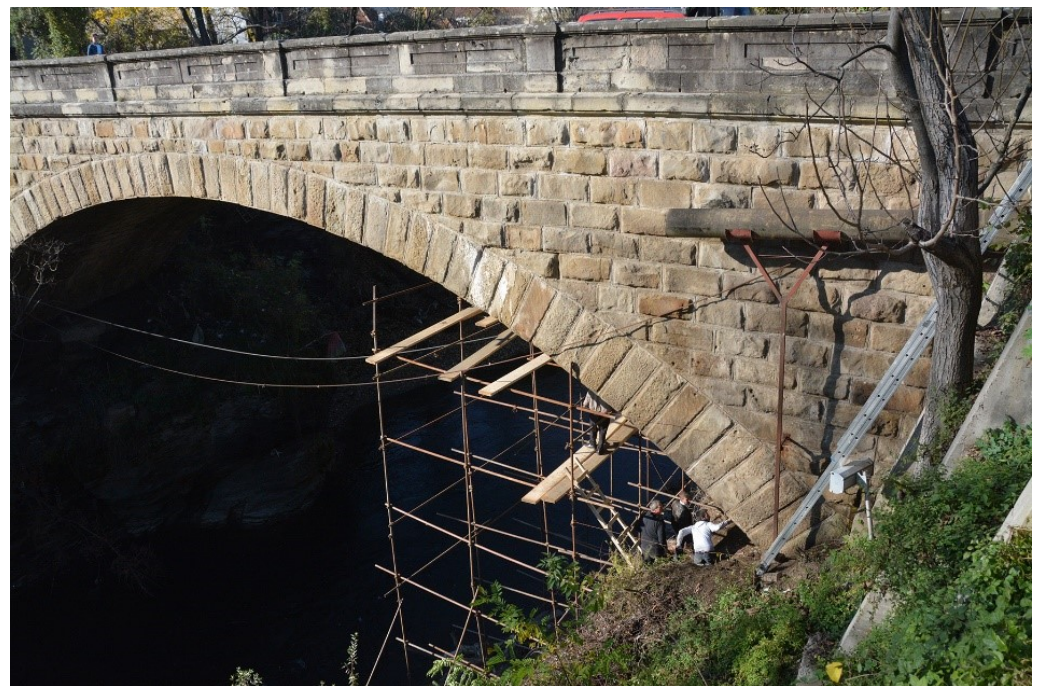
Figure 5. Elevation of the spandrel and wing wall with arch ring showing the dimensions and relation between stone blocks from which it was built and their current state.

Parapet and belt course were also made of natural sandstone with punch finishes. Belt course stones' height is approximately 20 cm, and it overhangs above the spandrel and wing walls, protecting them from changeable climatic conditions. The exposure to environmental effects affected the stone and led to the decay of some parts. Stone testing has proven that the parapet has suffered severe deterioration [30], followed by the building up of sediments, bio-colonisation, stratification, falling or loss of stone material (Figure 5).

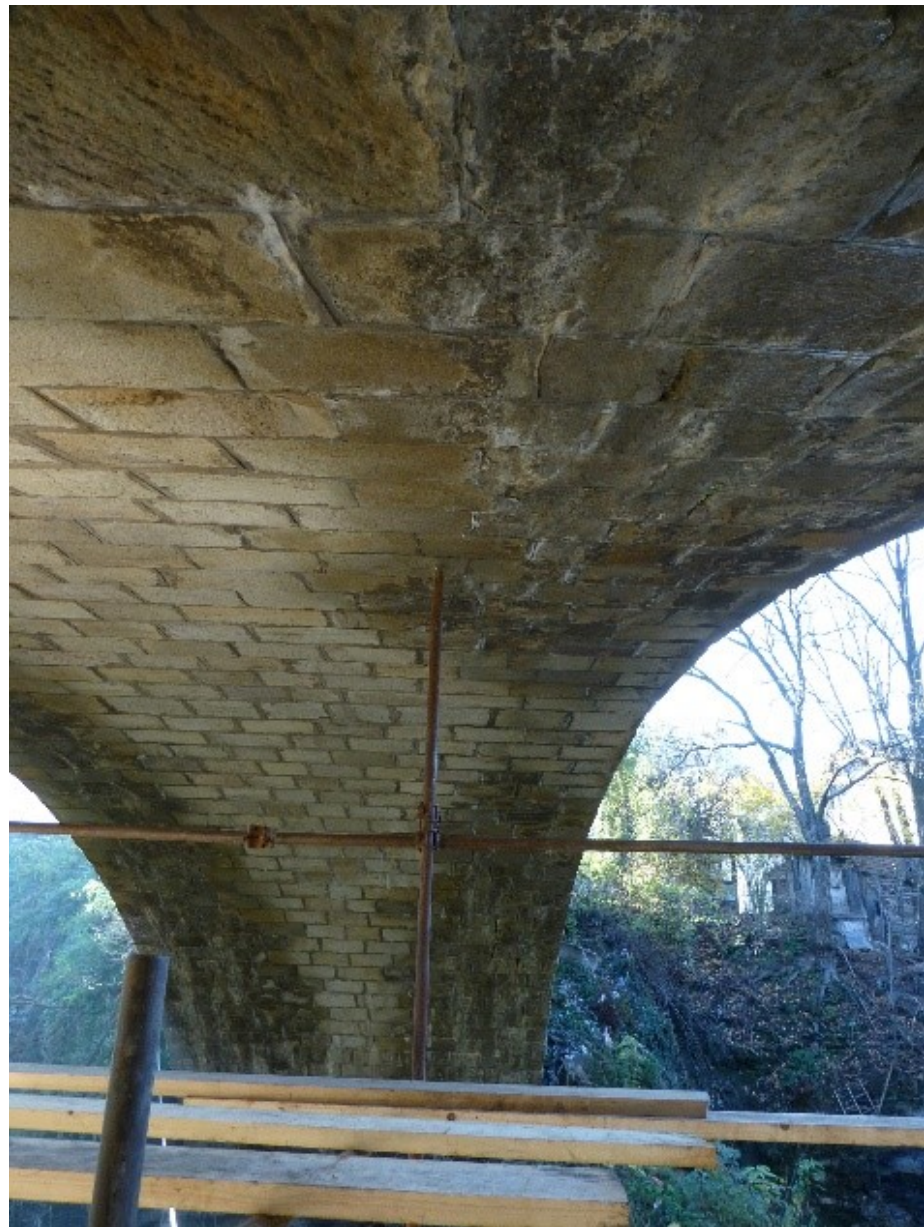
Figure 6. Elevation of the arch barrel where deterioration of alternately built-in stone blocks and the visible difference between the central-dry and side-wet sides of the arch barrel.

The deterioration of stone structure, presence of moisture and of longitudinal cracks were spotted by visual inspection. The presence of moisture on the arch barrel is more significant on the northern side and near its side edges (Figure 6), as expected. Longitudinal cracks were formed in several places, following either the stone structure of the bridge or its joints. The greatest cracks are in the crown zone, while there are none near the foundations. Observation of the exact position of the cracks (Figure 4) shows that the cracks are near the edges of the arch barrel, i.e., shorter cracks are 50–75 cm from the edge and a great crack is 135 cm from the edge. The observation showed that these cracks are related to the change of zones (Figure 7), from motor vehicles to pedestrians, which will be discussed later in the paper.

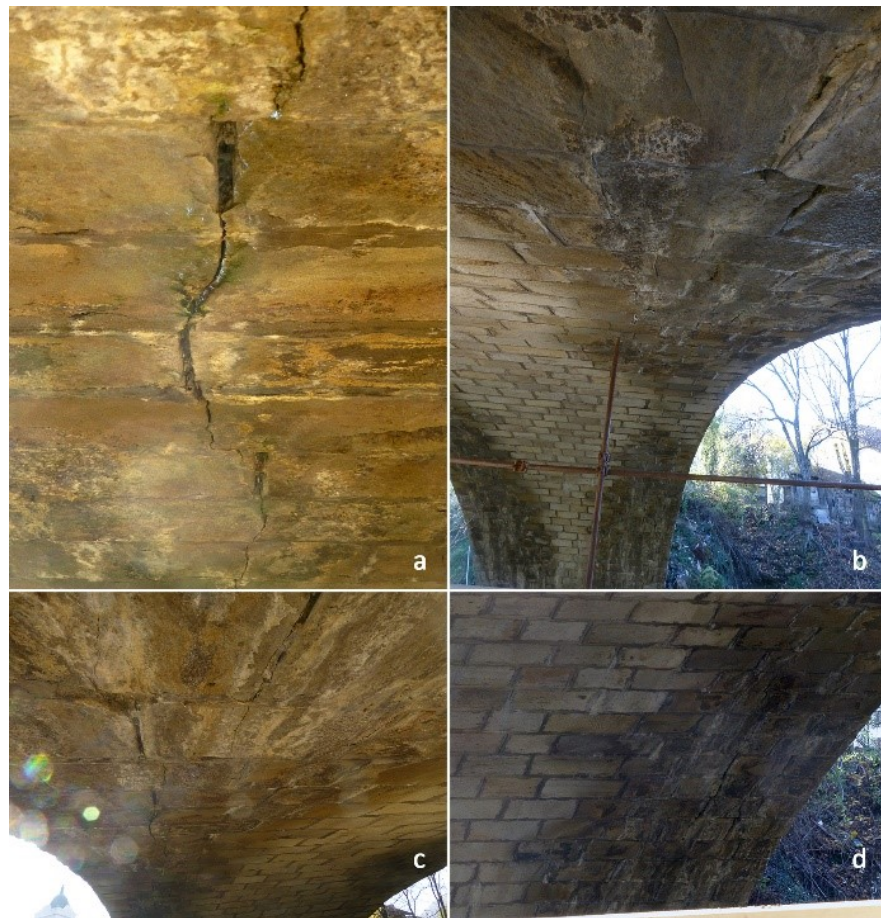
Figure 7. Photos of arch barrel cracks (a) between and through stone blocks, (b) on the wet side of the arch barrel, (c) through binder and (d) on the lower third of the arch barrel.

If we notice the location of the cracks, it is possible to see the location of the greatest crack on the bridge in the same area where the greatest deflection changes happen, on the line which separates the sidewalk from the roadway. For instance, if there are no users on the sidewalk, deflections will result only from self-load. In addition, if in the same moment a vehicle of the category V600 passes, in position p12, i.e., approx. 5 m from the edge of the bridge, the most significant difference in deflection under the sidewalk and roadway will occur. Thus, the difference is $\Delta f = 4.20$ mm and it will cause the appearance of a longitudinal crack that will strive to separate the bridge in two segments. As the most significant crack was spotted on the line between the sidewalk and roadway, the conclusion is that this crack results from the deformation's amplitude, which occurs under the minimum and maximum loads. There are also the greatest shear stresses in the same area due to the transverse forces which influence further bridge structure damages that appear among stone joints and directly through stone blocks.

A case study showed that the leading cause of the longitudinal cracks are shear stresses that appear when the live load is applied. Significant shear stresses in the transverse direction are expected in the barrel, as the live load defined by standards for vehicle zones is much higher than for pedestrian ones. This leads to fractures in stone structure because of the low capacity of sandstone to shear stresses. The appearance of these cracks did not lead to the collapse of the bridge, as they show limited bearing capacity in the transverse direction, but to the formation of an alternative structural solution, two independent arches. On the other hand, following the ingress of moisture, the existence of a crack leaves an open path for the moisture entrance, thus continuing the process of degradation of the inner structure. It is well known that, even though moisture does not directly influence mechanical degradation, its impact on the degradation of the material's inner structure is significant. The city of Ivanjica, which belongs to the Moravica district, is famous for its large temperature oscillations, which is a condition that favours processes of physical degradation of material in the presence of moisture content. To investigate potential future behaviour of the bridge that could lead to the collapse, three possible mechanisms have to be evaluated: the opening of additional hinges in the arch barrel, which could lead to the formation of the mechanism; the out-of-plane behaviour of the spandrel wall; and the possible rotation of different parts. This is because the longitudinal crack forms two "L" cross sections, whose rotation might lead to the collapse of the system. All three possible failure mechanisms should be investigated more thoroughly to define the limit conditions of the subject of this case study, thus defining its serviceability. Although a significant reserve of strength exists even after the crack formation, the weathering cycles and vegetation growth, recognised and investigated in this research, will modify the structure's stiffness. In this context, it is essential to provide remedial measures directed towards cleaning biological colonisation and repointing the crack to prevent moisture ingress, allow movement and independent behaviour of separated parts.

- Clean the structure from biological colonisation to stop potential further degradation.
- Prevent moisture ingress by repointing the crack with a flexible grout that would not compromise the new-defined behaviour of the structure but close the path for moisture entrance.
- Follow the propagation of cracks and their activity when the live load is applied.
- Investigate possible failure mechanisms, evaluate them in order to predict future behaviour of the structure and set possible restrictions on its use.

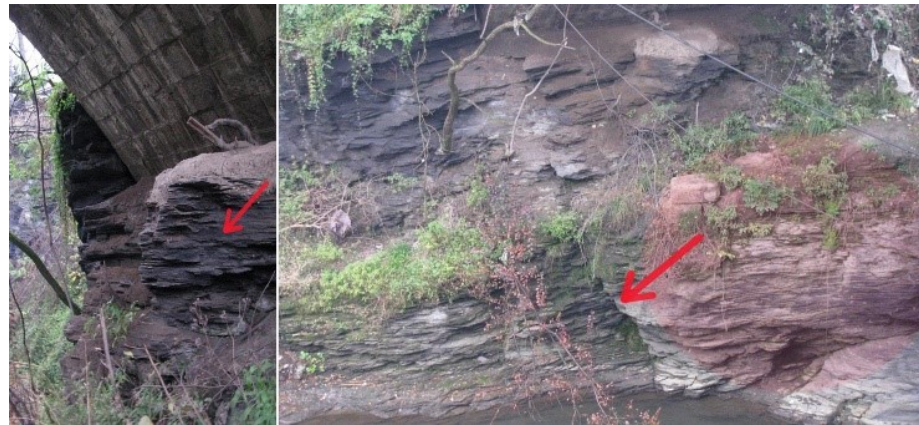
Figure 8. Cracks and rift in the rocky mass under the bridge foundation observed at site.

The measurements and observations showed no movements and changes in the bridge structure that would significantly affect the structural stability. To prevent the loss of rock material and the creation of rifts and cracks, it is necessary to maintain the environment around the foundation and prevent the destruction of rocks triggered by vegetation emerging in the cracks of the rocks.

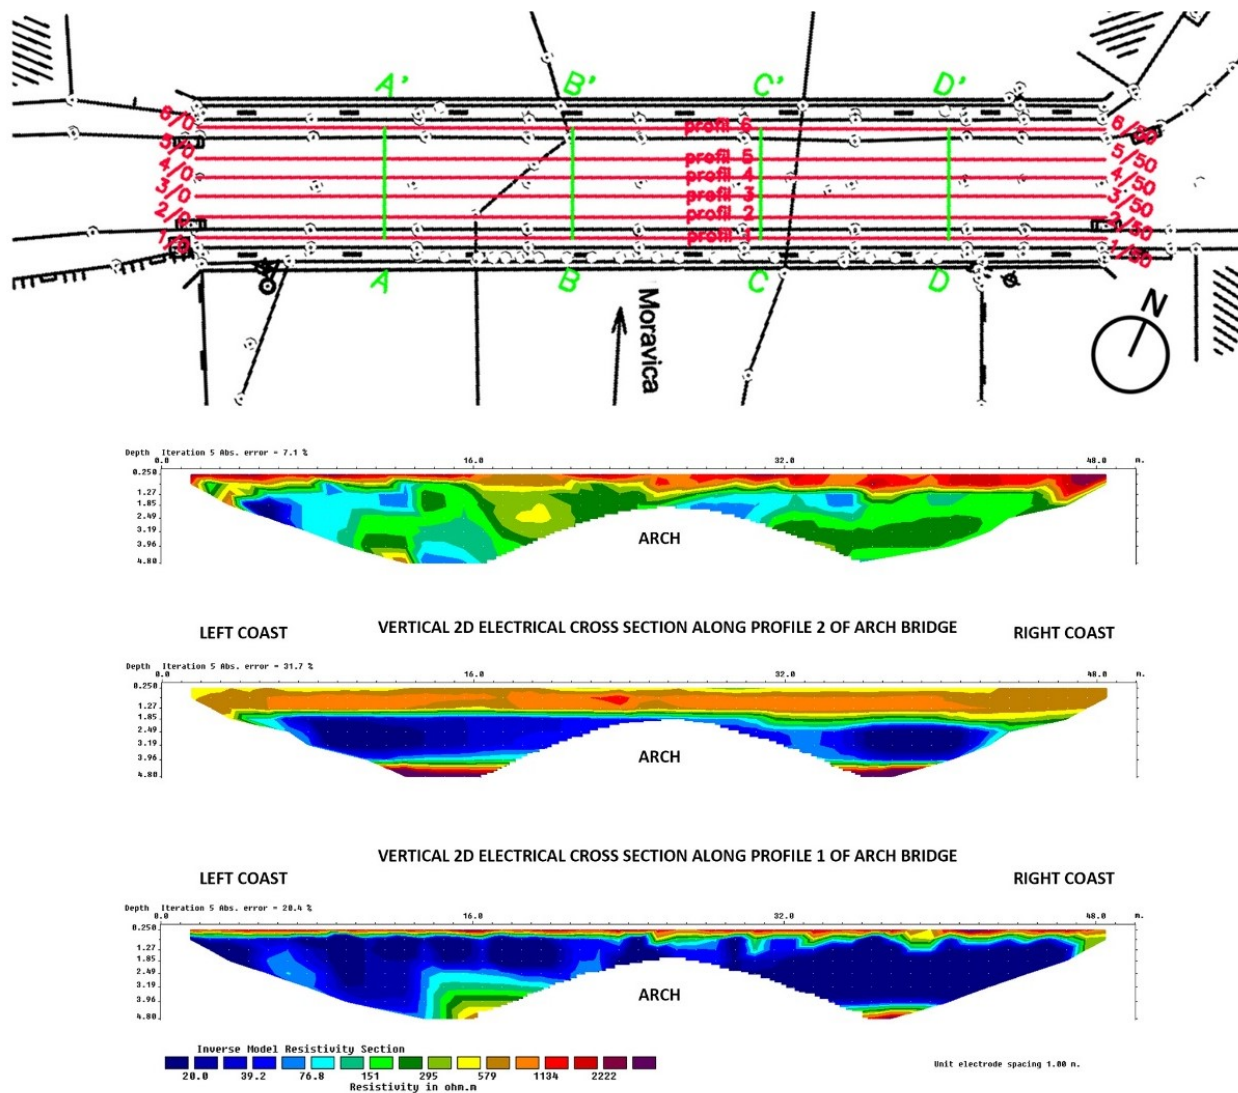
Figure 9. Geo-electric scanning with results of the distribution of electrical resistivity in $\Omega \cdot m$ showing the change in dryness of the material from left to the right coast of the bridge (from top to bottom: plan with profile positions, profile 3-3, profile 2-2, profile 1-1).

Based on the results analysed, it was found out that the infill of the bridge is heterogeneous and well-compacted rock fragments and pottery are most likely present mixed materials. The obtained electrical resistivity values vary extensively, from 40 to 80 to over 3000 $\Omega \cdot m$ (from blue to dark red colour on the legend of obtained 2D electrical models). Inside the bridge, there are no cavities filled with water or air in the filling zone, affecting the pavement ribbons' settlement. Lower electrical resistivities from 40 to 80 $\Omega \cdot m$ (variants of blue on the legend of obtained 2D electrical models) are most likely due to the significant presence of moisture in the materials. There is no doubt that the filling materials in the bridge's construction have often been there before being moistened by atmospheric precipitation. Higher values, from 500 to over 3000 $\Omega \cdot m$ (from yellow to dark red on the legend of obtained 2D electric models), indicate the presence of drier materials, both in the filling zone and immediately below the pavement and pedestrian trail. Immediately below

Through the comparative analysis of the position of the cracks at the arch bridge and the results of the geo-electric scan, it can be noticed that the cracks are most pronounced between the profiles 1-1 and 2-2 in the longitudinal section, that is, positioned around the C-C profile to the D-D profile in the cross section. By cr-cutting these profiles, it can be concluded that the lowest value of electrical resistivity (blue colour) was recorded in the cracks due to the presence of moisture in the fill. As mentioned above, under the traffic load, the filling puts pressure on the side walls, which can cause separation of the wing walls of the bridge from the vault, causing the appearance of longitudinal cracks. This lateral pressure is higher and more pronounced if the fill of the bridge is moistened.

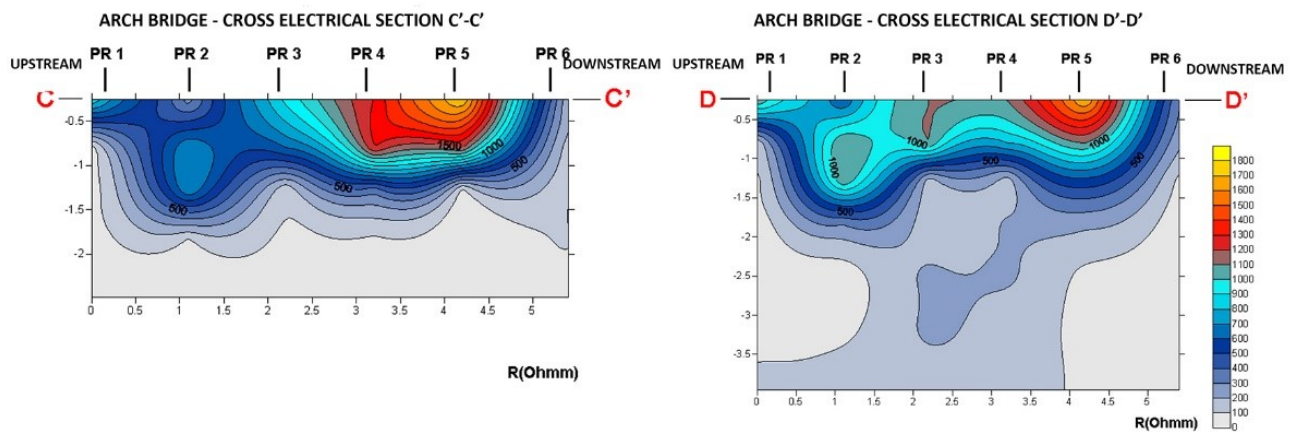
Figure 10. Geo-electric scanning with results of the distribution of electrical resistivity in $\Omega\cdot\text{m}$ showing the change in dryness of the material from traffic road to the arch barrel (from left to right: profile C-C', profile D-D').

However, it should be noted that lower electrical resistance is due to the presence of moist material, very likely in the fill of the bridge, due to its inability to be drained by gravity. Moreover, by observing the bridge, it was noticed that its parts closer to the edges, primarily located on the north side, are affected by moisture, which can potentially endanger the structure of the stone material. To prevent damage of the bridge under the influence of water and moisture, it is necessary to check the drainage channels and waterproofing of the bridge during the repair.

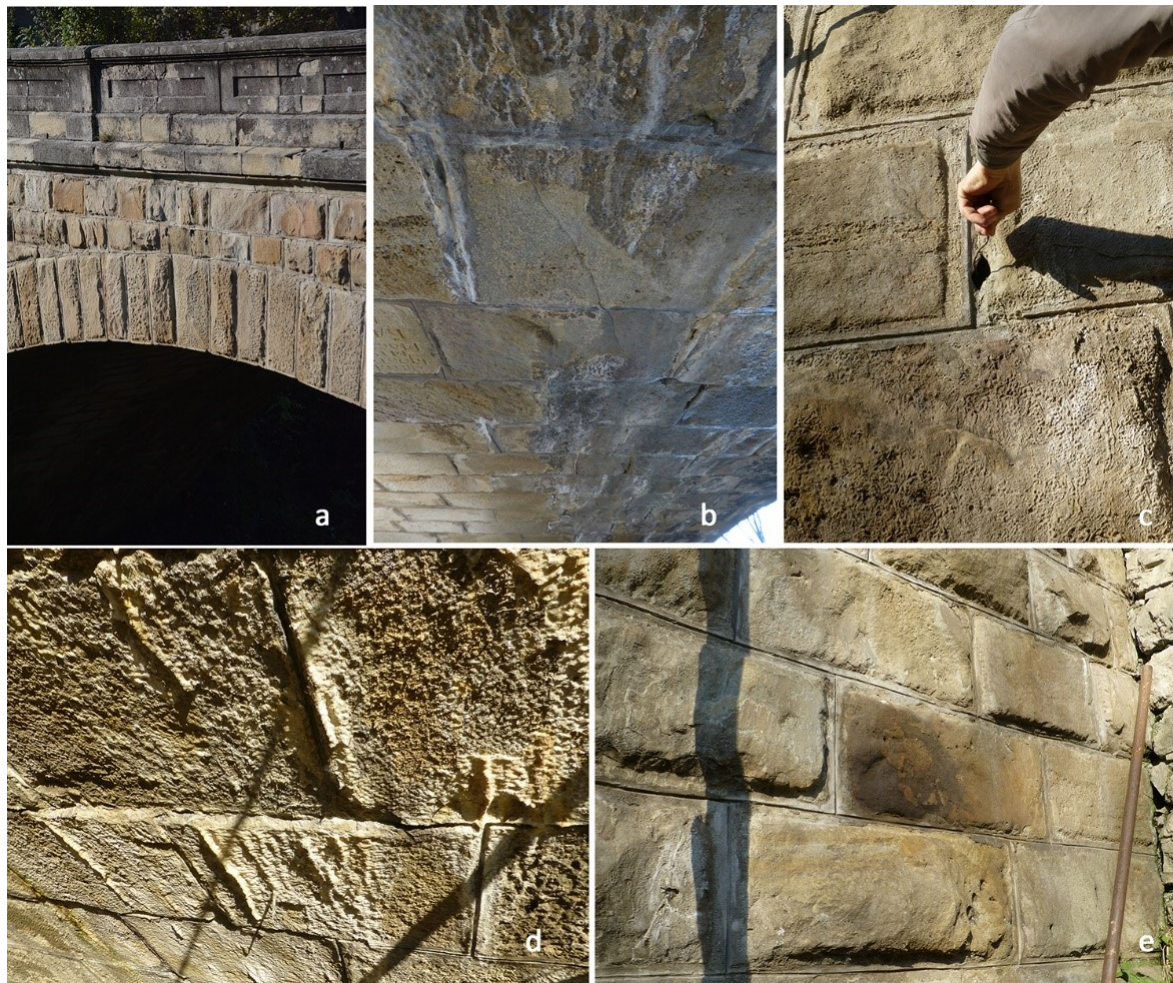
At the face of the bridge, seen from the upstream side, several spots are observed in the spotlight in the form of white stains and edges (Figure 12b), indicating the direction and level of circulation/movement of moisture that was carried by dissolved salts. Moreover, the efflorescence can be seen on the arch barrel (Figure 12d). Though visible to the naked eye, this form of degradation, apart from aesthetically diverting white stains, is less harmful than subflorescence, which mechanically destroys the stone structure inside the assembly. In the northern part of the bridge, the dominant bio-colonisation is represented by lower plants (lichens, algae, mushrooms and moss) and, to a lesser extent, by higher plants.

By biological testing, a high degree of biodegradation of the surface of the embedded stone was determined, and in the well-developed biofilm, there are lichens, moss, RIF (microcolonial mushrooms), filamentous micromycetes, yeasts and bacteria. Chemical testing on a sample of hardened crust from the vault of the bridge diagnosed that the crust is brighter, with a thickness of up to 3 mm, and that in the composition of this crust is CaCO₃.

Figure 12. Close-up of bridge structure: (a) decolorisation of the parapet and spandrel wall, (b) forming of white stains and edges, (c) sampling for biological analysis, (d) efflorescence of arch barrel and (e) change of colour on the wing wall.

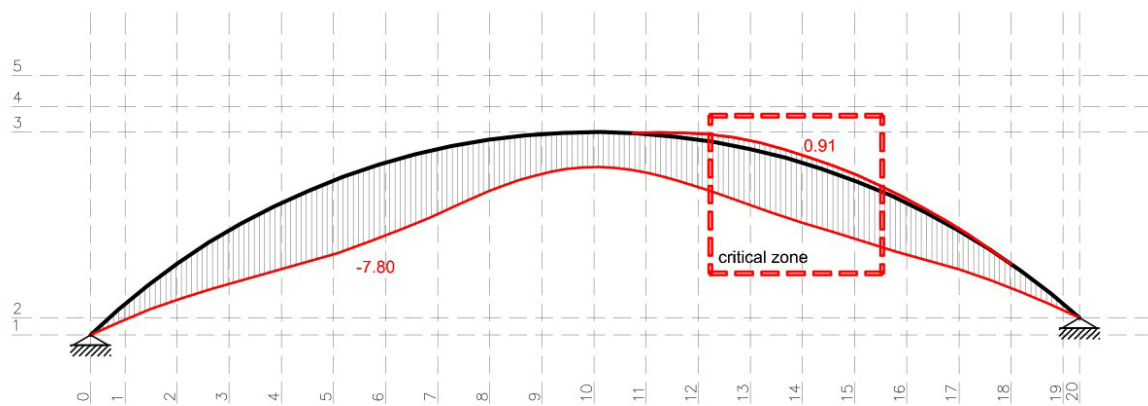
Figure 16. Envelope of minimum and maximum deflections on the construction under every load case in $f(\text{mm})$, with highlighted position of the largest amplitudes resulting in longitudinal cracks on the arch barrel.
