The Use of Natural Stone as an Authentic Building Material for the Restoration of Historic Buildings in Order to Test Sustainable Refurbishment: Case Study

This study deals with the restoration and adaptive re-use of the abandoned buildings within the Haybarn complex on Mount Athos, in Greece, in order to improve the energy performance, to contribute to environmental protection and to maintain the authenticity of these buildings. The use of stone as the main building material on Mount Athos is a consequence of its availability and easy extraction. Stone is a natural material extracted from natural deposits called quarrying. Stone needs very little maintenance, and after a simple method of stone processing, it is turned into construction material. Building stones were widely used in the Middle Ages for massive foundations, walls, domes or vaults. Several types of stone were used for decorative facade ornaments, the interior design of these buildings as well as for indoor flooring. Natural stone slabs, used as a roofing material, were almost untreated (Figure 1A). This stone roofing technique still stands in some Mount Athos buildings. Numerous structures within the monastery comple

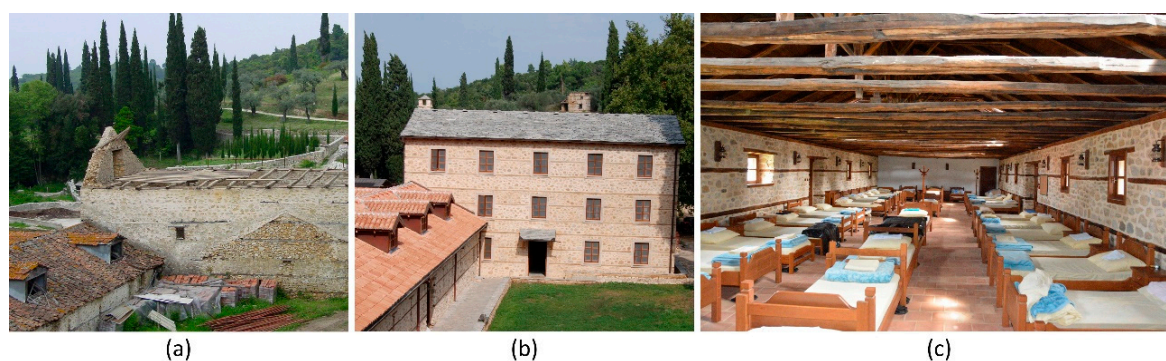
Figure 2. The Haybarn Complex: Mulekeepers' House, Stable, Haybarn (from left to right): (a) former appearance, (b) post-restoration appearance, (c) the interior of the Stable after the restoration (provided photos taken by the author).

The purpose of the restoration of the Haybarn Complex was to keep all undamaged parts, remove the demolished ones and to rebuild the damaged walls using the authentic material, using the natural stone as authentic material. During the restoration, the old mud or lime mortar was replaced with a new binding agent, lime cement mortar. All the construction measures were realized in accordance with the conservation requirements; the stone façade walls, roof structure, roof covering and the authentic appearance of the building were not to be changed.

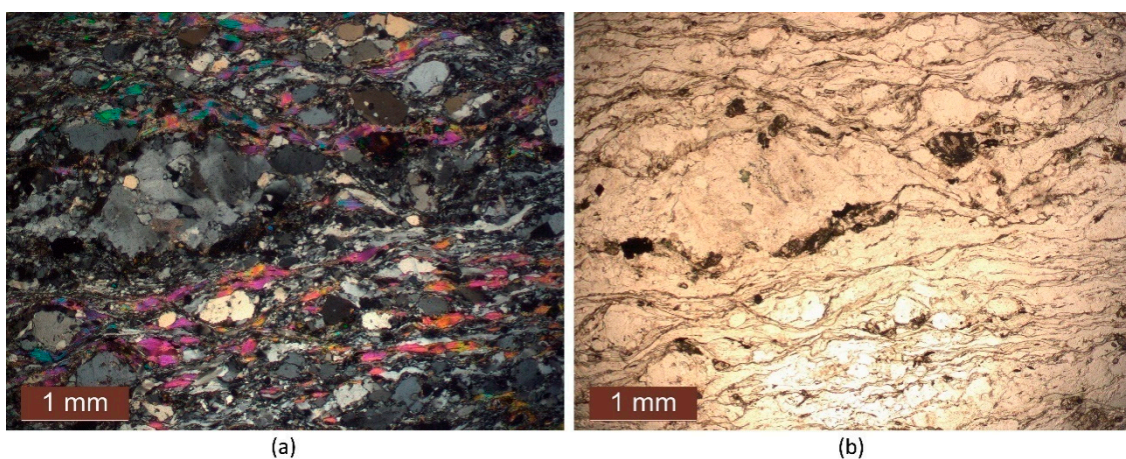
The petrographic analysis of sample 4, taken from this new roof slab, has established that the stone type is an epidotic gneiss-micaschist (the old geological name leptinolite), which most likely originates from the Serbo-Macedonian mass. The rock has a lepidoblastic and granoblastic texture and schistose to augen structure. It is formed from more than 85–90% quartz, mica, feldspar and epidote, and the rest consists of chlorite, calcite, sphene, apatite, tourmaline, zircon and iron oxides and hydroxides. Figure 8 shows photomicrographs depicting one thicker stripe which is transformed into a lens formed by quartz and plagioclase, surrounded by a matrix of elongated muscovite lamina and quartz lenses. This is the general appearance of the rock, although some millimeter-thick stripes appear, which are only formed from quartz. In Figure 8 with parallel nichols, there are several epidote porphyroblasts that stand out with a high relief.

Figure 8. The photomicrograph structure of sample 4 rock, epidotic: gneiss-micaschist: (a) With crossed nichols, (b) With parallel nichols.

- As for the restoration of the Haybarn Complex, the installation of a partially new roof covering instead of old, deteriorated and demolished stone tiles, is a partial use of another type of stone that does not belong to the Mount Athos area, which is a novelty of the multi-century practice. The novelty does not affect the visual quality of these buildings.

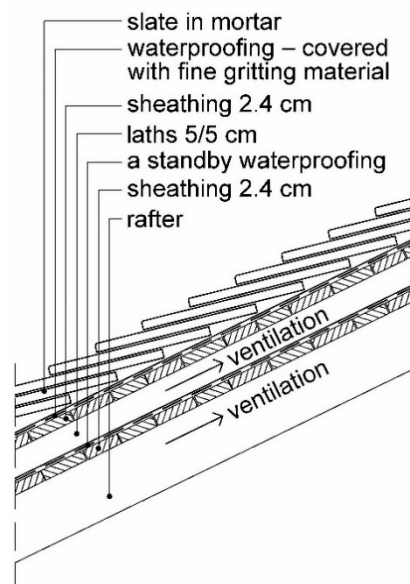
It is possible to keep the slate roofing, as an authentic roofing structure, and visual identity of the heritage buildings, if the following modern principles of double-skin ventilated roofs are applied [6]: ventilation of roof space and ventilation of stone-coated roof (above the waterproof layer), i.e., the condensation drying [28] that occurs on the lower sides of the stone slabs at dawn, as well as drying out the moisture that is the result of water penetration between the stone slabs.

Figure 9. Recommended restoration of the slate roof covering—the applying of the double ventilation modern principles.

The roof restoration was the process of applying the layers of roof coating, according to the building engineering physics, as presented in Figure 9.

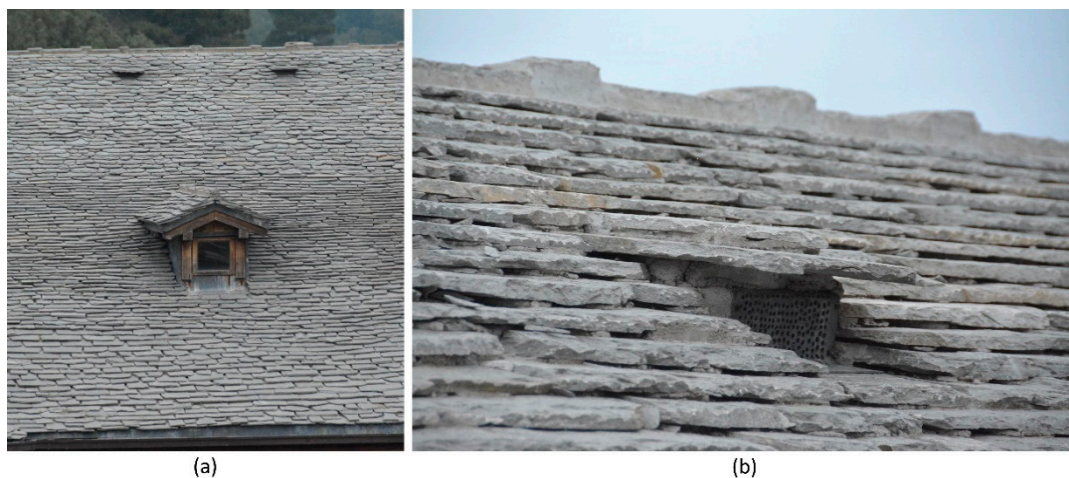
Figure 10. Venting during the restoration of the slate roofing: (a) roof appearance, (b) roof air vent (the photo taken by the author).

The use of stone for the building roofs starts at the eaves, thus enabling the penetration of air and interrupted airflow between the wooden slats, parallel to the eaves. The installation of ridge vents is required as well (Figure 10).
