# REHABILITATION PROJECT OF AN APARTMENT BUILDING IN BELGRADE, SERBIA

*Milica Jovanović-Popović, Dušan Ignjatović, Nataša Ćuković-Ignjatović,  
Ana Radivojević*

*As a part of a scientific project conducted at the Faculty of Architecture University of Belgrade a detailed survey of building fund has been made and a typical 1950's building was chosen as a demonstration project for the energy conscious renovation and retrofit procedure.*

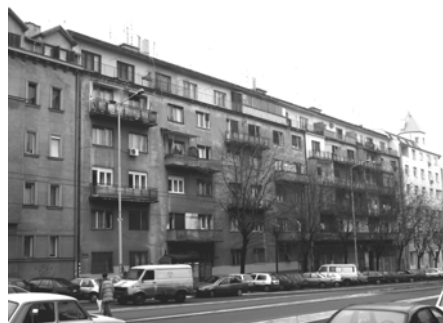
Figure 1: Building in Cvijiceva 112-120: street (North) façade – existing state

Finally, the building in 112-120 Cvijiceva street built in 1957. was chosen to be the subject of the pilot project (Figures 1 and 2). It was built within a traditional city block, it has all the characteristics of designated building type, with street façade facing north and court façade facing south with courtyard wide enough to provide good solar exposure. The building was in rather poor condition, and needed some refurbishment and repairs that the owners could not carry out themselves.

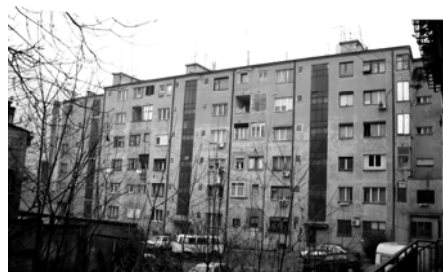
Figure 2: Building in Cvijiceva 112-120: court (South) façade - existing state

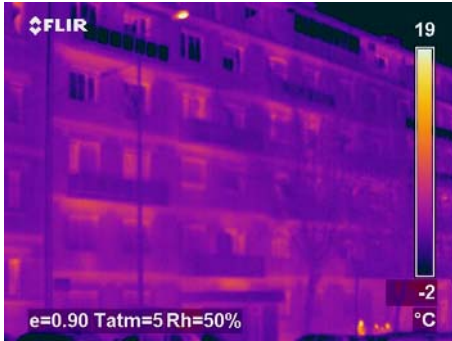
Figure 3: North façade – thermographic image

Later during the research, when thermal camera was acquired, thermal images showed the patterns of heat losses and identified the most critical parts of the building regarding its energy performance. Figures 3 and 4 show that the most evident losses occur in the areas

where concrete slabs intersect with the façade and on the windows. Some variations are visible on the South façade (Figure 4) where tenants have used their loggias as extension of living space, having them enclosed in their own way.

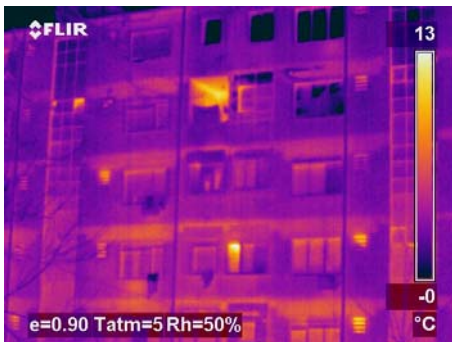
Figure 4: South façade – thermographic image

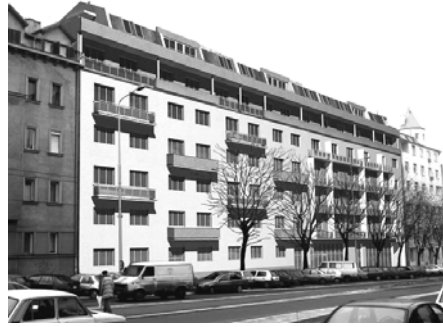
Figure 5: North façade – the first phase of reconstruction

Figures 5 and 6 present the perspective views of the North and South facades as designed for

the first phase. The design was approved by all participating parties.

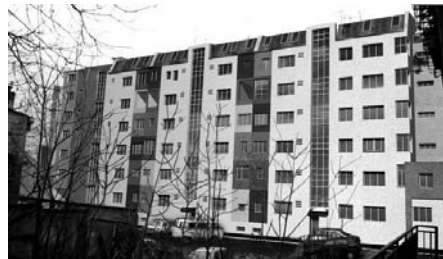
Figure 6: South façade – first phase of reconstruction

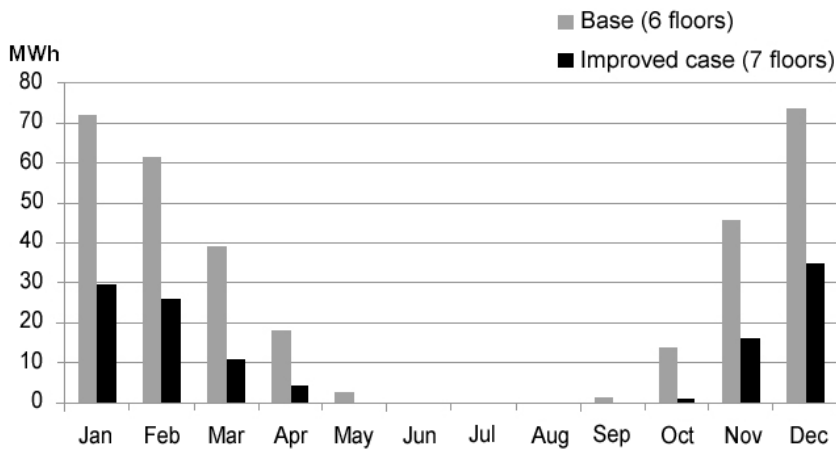
Figure 7: Annual energy load for heating

First phase of rehabilitation was mainly focused towards reaching the desired energy standard and level of comfort as well as improving the overall state of building. For the Base case and for the Reconstructed case the dynamic building model (DOE 2.2) has been established. The theoretical estimations of energy consumption showed that the annual amount of energy used for heating could be reduced up to 63% (Figure 7).

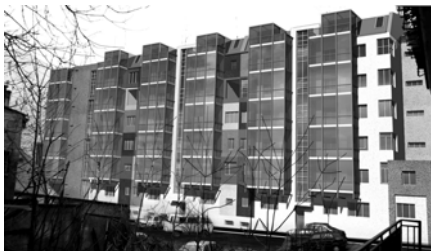
Figure 8: Reconstructed court façade – phase 2.

In this phase new structure was added on the south façade (Figure 8). This structure serves both as a thermal buffer zone and an extension of existing flats. Constructed from steel frames and glass covering it is connected directly onto the primary structure of the building serving as a sunspace to which every flat can be extended. Sufficient internal shading in the form of Venetian blinds and lateral openings were designed to prevent overheating in summer period.

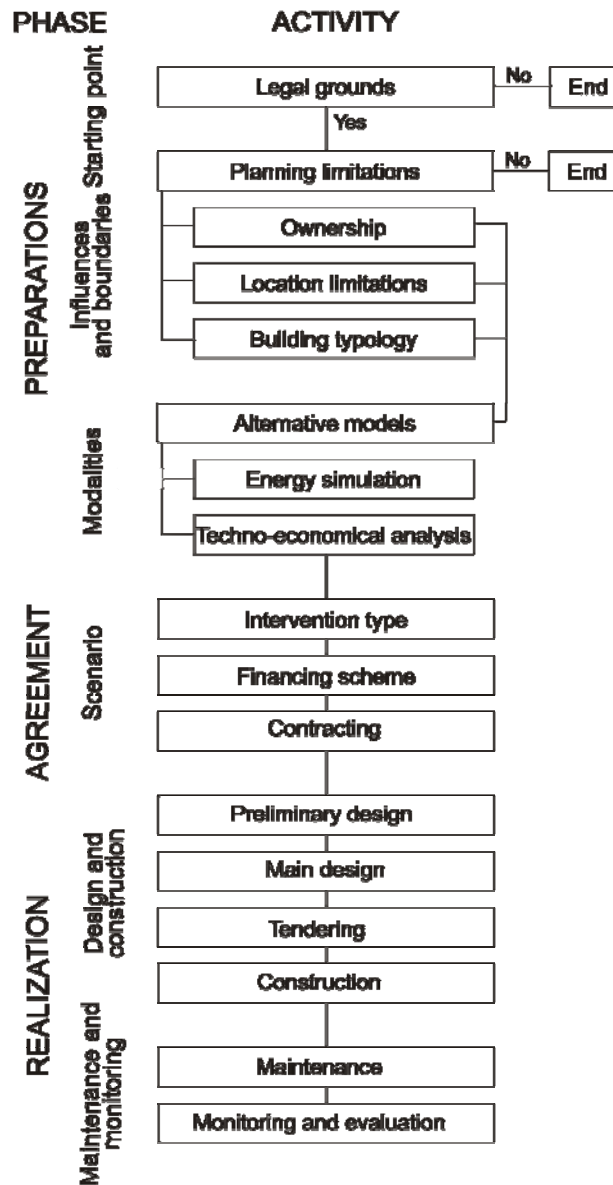
Figure 11: Algorithm for energy optimisation

The primary goal of the pilot-project was to optimize the energy performance of the selected building, using the methods and resources that could serve as a model scheme for future interventions, preferably carried out by the tenants/owners with some encouragement and support from the municipality level. Figure 11 shows the algorithm with phases and corresponding actions that should enable the complete realization with monitoring and evaluation providing data on real benefits of intervention. This algorithm was elaborated having in mind not only the participants in the particular pilot-project, but the real actors that would be involved in a similar process elsewhere in Belgrade metropolitan area [4].

The absolute preconditions for the interventions are solid legal grounds, where complete accordance with planning limitations is required in order to make any intervention legally possible. Preparations phase covers analysis of limitations deriving from local characteristics of particular site, building type and ownership status. In search for modalities of intervention, alternative models can be proposed with energy simulations and techno-economical analysis that could help clarify the most suitable intervention type. For the chosen intervention, financing scheme is elaborated and at that point contracting can begin. Realization covers all standard phases, from preliminary design up to the construction and should be followed by adequate maintenance and involve monitoring and evaluation that would provide feedback data if possible.
