THERMAL BRIDGES IN BUILDINGS AS A RESULT OF URBAN TRANSFORMATION

Aleksandar Rajčić

University of Belgrade, The Faculty of Architecture, Serbia
rajcic@arh.bg.ac.rs

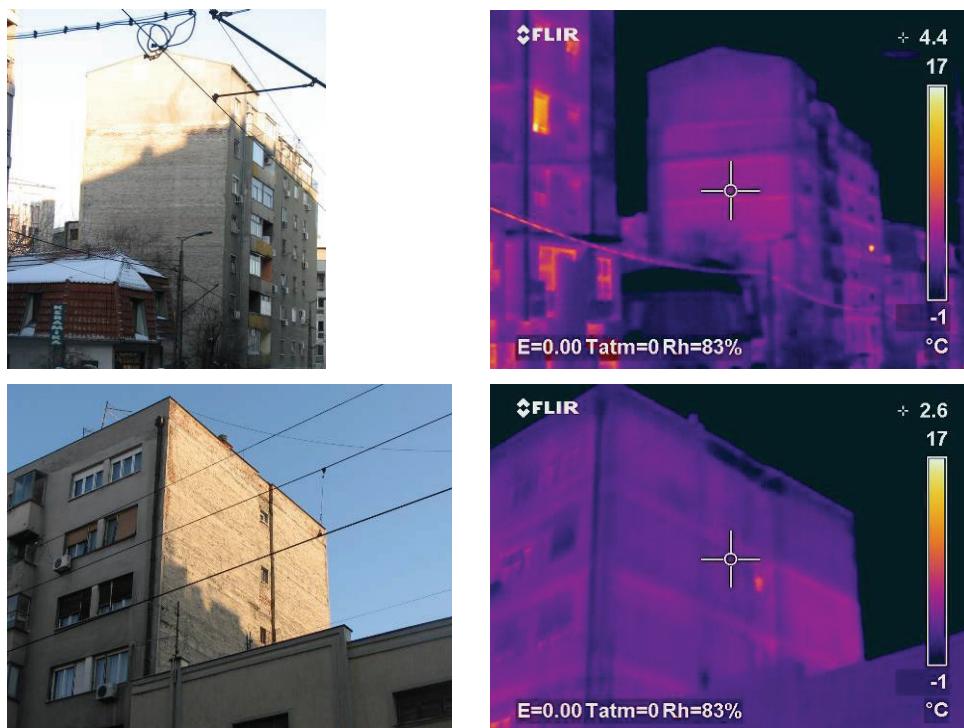
multi-family buildings from the 1960s have remained with exposed bare gables. In view of the period in which they were constructed, their walls of brick are not insulated, and there are no insulated floor structures (Fig. 1).

The following is evident on thermo-vision images:

- Increased heat flow in floor area constructions
- Different modes of heating in a single dwelling, since these buildings are not connected to the city remote central heating system, so that it can be seen that some rooms are heated while others are not.

Fig. 1 Examples of free non-insulated side walls of multi-storey apartment buildings

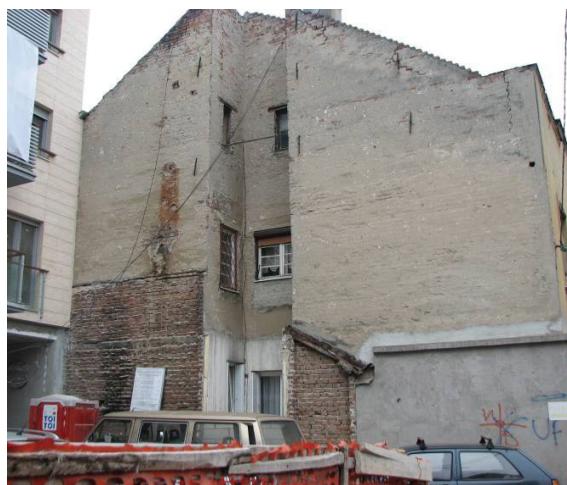
In the analyzed example, the old house from 1937 was left with bare gable walls, because the small adjacent pre-war houses were destroyed and in 2010 a residential building GF +7 was erected (Fig. 2).

During the long period of service, before this urban transformation, problems did not occur in the interior, although a wall made of solid brick, 25 cm thick, plastered outside with lime mortar, was largely damaged with the passage of time. The floor construction above ground floor is a full reinforced concrete slab, 12cm thick.

After demolition of the old adjacent house, the corresponding side wall is bare, the storey reinforced concrete slab is unprotected out on the facade, and an additional aggravating factor is the non-plastered facade area, with unfilled joints.

Fig. 2 Side (gable) wall of the old house

The only correct and durable construction intervention, in this case, is the application of external thermal insulation, with adequate protection of the facade, which actually causes new problems (stated above).

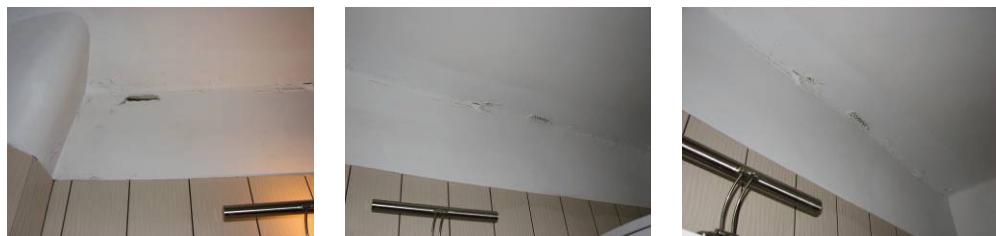
During the autumn and winter months, mould occurred in the bathroom, at the junctions of the wall and ceiling and the wall and window (not directly related to the considered connection).

This did not yield results, because after 10 days, the anti-fungicidal coating began to flake, and in these parts mould once again formed colonies (Fig. 4), clearly expressed as the result of additional heat flow caused by the thermal bridge (Fig. 5).

Fig. 4. Photo bathroom interior (junction: wall – ceiling)

Due to the impossibility of external intervention, repairs from the inside were accessed, the mould was removed, and anti-fungicidal coating was applied (Pherma white).
