Inspection and Assessment of Masonry Arch Bridges: Ivanjica Case Study

Citation: Sokolović, N.M.; Petrović, M.; Kontić, A.; Koprivica, S.; Šekularac, N. Inspection and Assessment of Masonry Arch Bridges: Ivanjica Case Study. *Sustainability* **2021**, *13*, 13363. <https://doi.org/10.3390/su132313363>

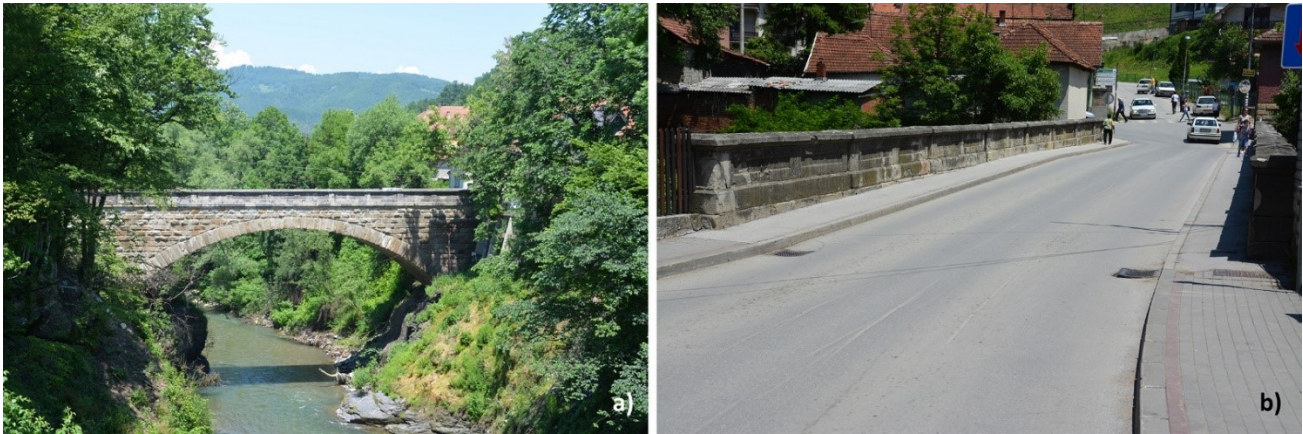
restoration. Because of the visible damages, since 2014, the heavy vehicles on the bridge have been banned. Nowadays, it is used by light motor vehicles and pedestrians only. This bridge is listed as the Spatial Cultural-Historical Unit of Great Importance in Serbia and protected by the state.

Figure 2. Masonry stone arch bridge in Ivanjica in its natural surroundings (a) and the traffic road of the bridge (b).

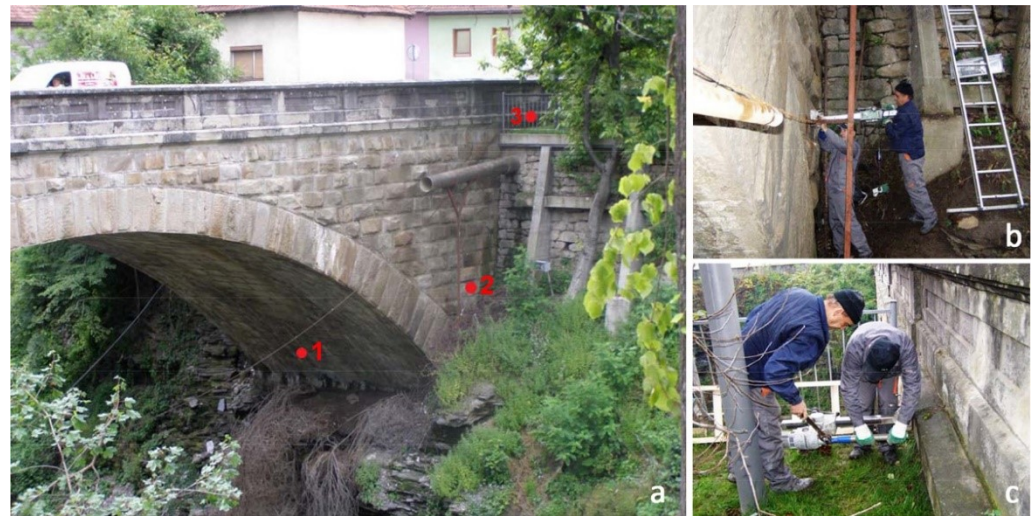
Figure 11. Taking a drilling sample for laboratory analysis: (a) positions of samples, (b) process of sampling the wing wall and (c) process of sampling the stone fence.

Studies have shown that sandstone with an arenaceous structure and cluster size between 0.05 and 2 mm and massive texture, or homogeneous assembly, was used to construct the bridge, which indicates a uniform quality of the built-in stone. The degradation process that led to the decay of stone arises to the depth of 1 cm, after which the stone is homogenous and does not show any signs of deterioration. Based on the tested values of the physical–mechanical properties shown in Table 1, we can conclude that according to the volume mass, the stone used belongs to a medium-hard stone, with high porosity and the water absorbency [33].

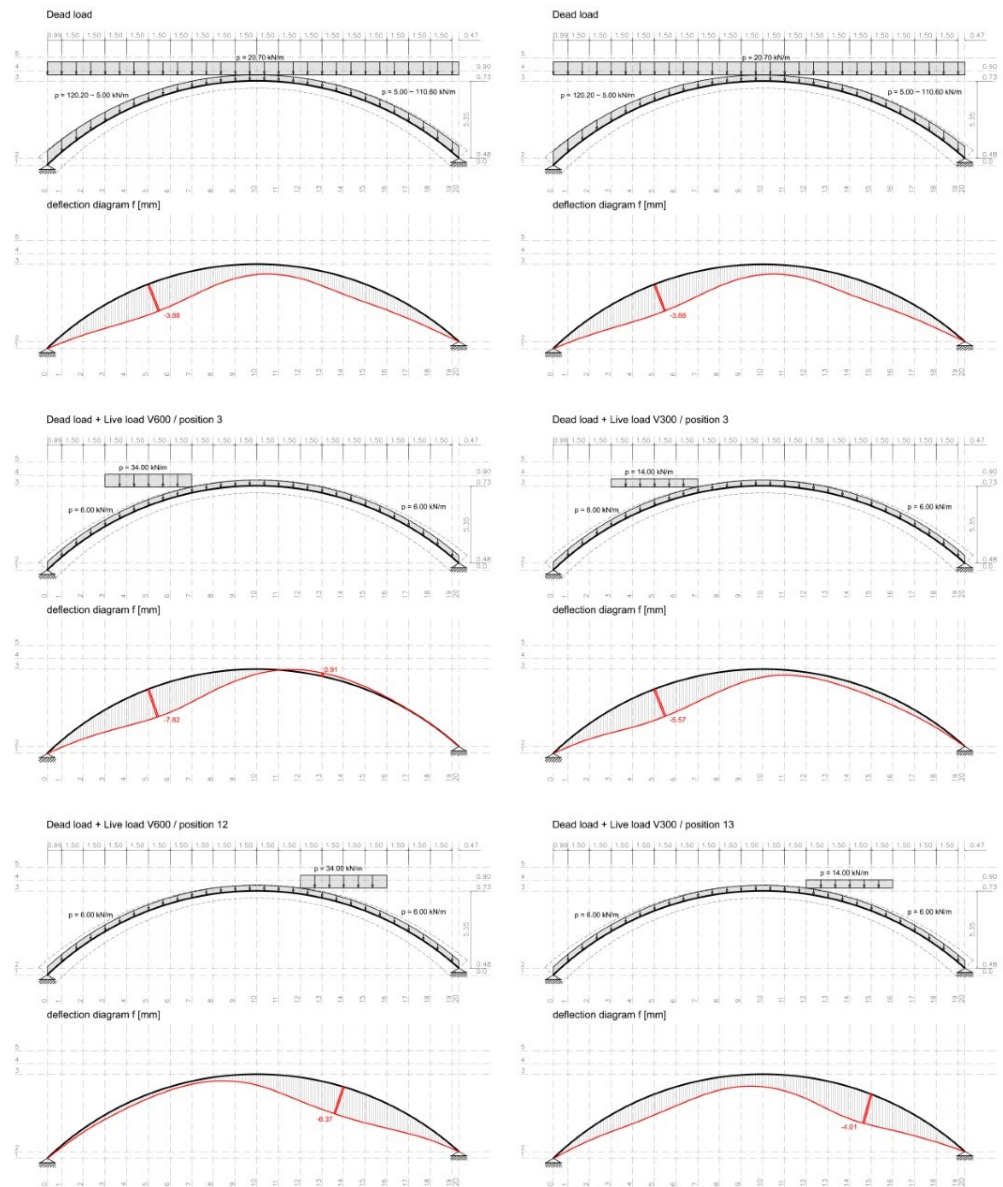
While observing the deformation model, i.e., the envelope of maximum and minimum deflection (Figure 15), the conclusion could be that the most significant absolute change in deflections occurs 20.40 m from the left support, at the part where large deformation from the live load V600/p12 was read. Deflections from dead load in that area are -2.14 mm, while the ones from V600/p12 are -6.34 mm, so the difference is $\Delta f = 4.20$ mm.

Figure 15. Diagrams of arch deflections in f (mm) due to different load conditions (from top to bottom: dead load, dead load + live load from V600/V300 positioned on the first third of the arch, dead load + live load from V600/V300 positioned on the last third of the arch).
