The Use of Natural Stone as an Authentic Building Material for the Restoration of Historic Buildings in Order to Test Sustainable Refurbishment: Case Study

This study deals with the restoration and adaptive re-use of the abandoned buildings within the Haybarn complex on Mount Athos, in Greece, in order to improve the energy performance, to contribute to environmental protection and to maintain the authenticity of these buildings. The use of stone as the main building material on Mount Athos is a consequence of its availability and easy extraction. Stone is a natural material extracted from natural deposits called quarrying. Stone needs very little maintenance, and after a simple method of stone processing, it is turned into construction material. Building stones were widely used in the Middle Ages for massive foundations, walls, domes or vaults. Several types of stone were used for decorative facade ornaments, the interior design of these buildings as well as for indoor flooring. Natural stone slabs, used as a roofing material, were almost untreated (Figure 1A). This stone roofing technique still stands in some Mount Athos buildings. Numerous structures within the monastery comple

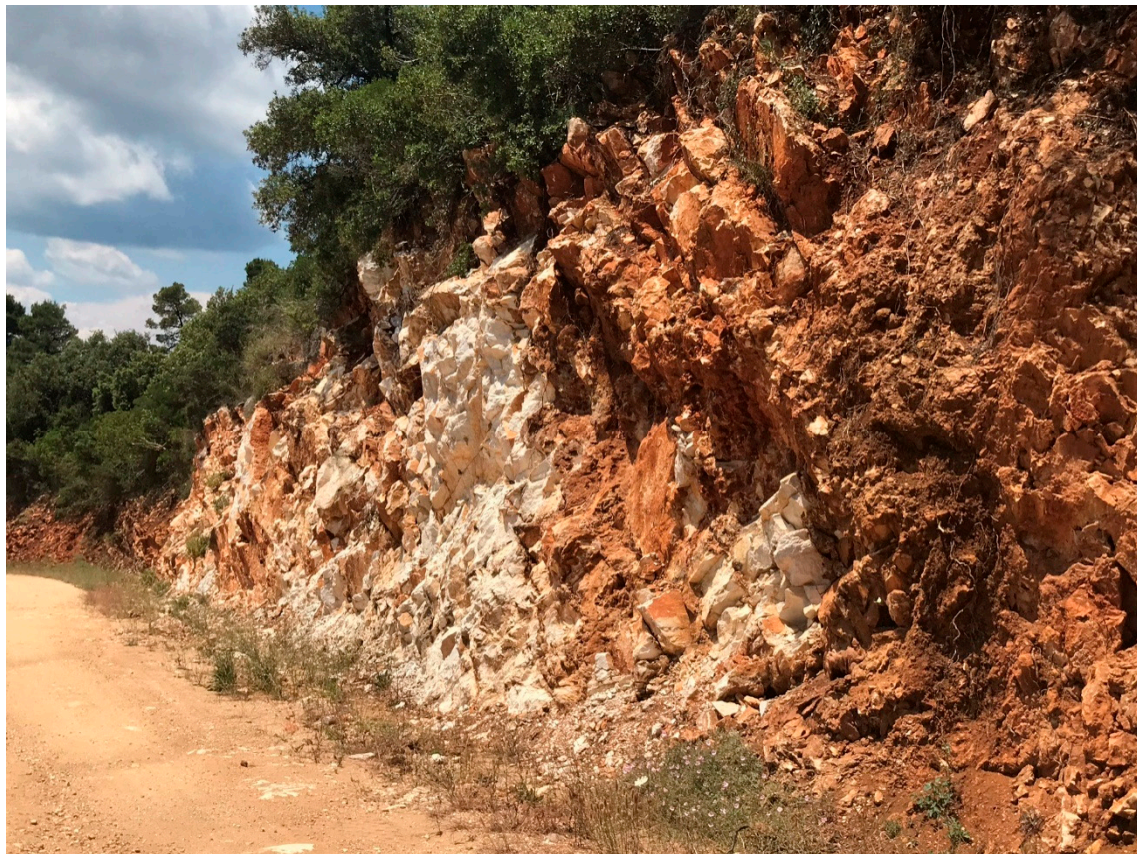
During the restoration of the Haybarn Complex, in addition to the use of the local stone as a building material, the stone taken from the stone deposit in a road, cut below Papa Konaki, near the Hilandar monastery (Figure 3) was also used. The petrographic composition of this stone is the same as the stone used as a building material for the entire complex at the beginning of the 19th century.

Figure 3. The stone deposit in a road-cut below Papa Konaki (provided photos taken by the author).

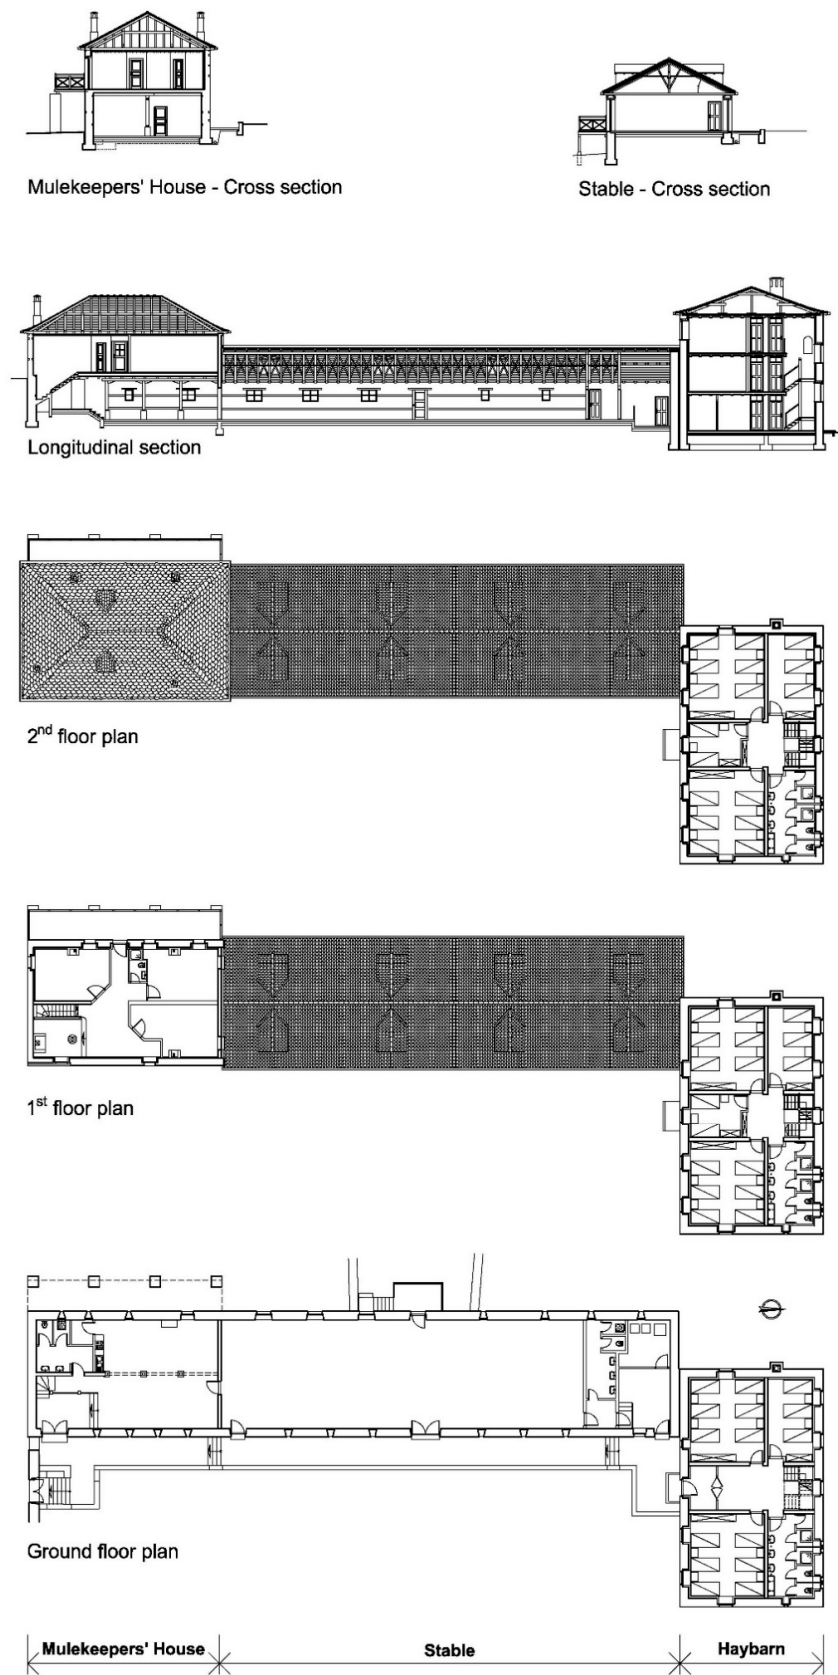
The mentioned construction measures and the materials used in the restoration, for the purpose of improving the energy efficiency of these buildings (Figure 4), have reversible characteristics, which means that the original condition of the restored buildings can be reestablished without causing any structural damage [26].

Figure 4. The Haybarn Complex (after the restoration).

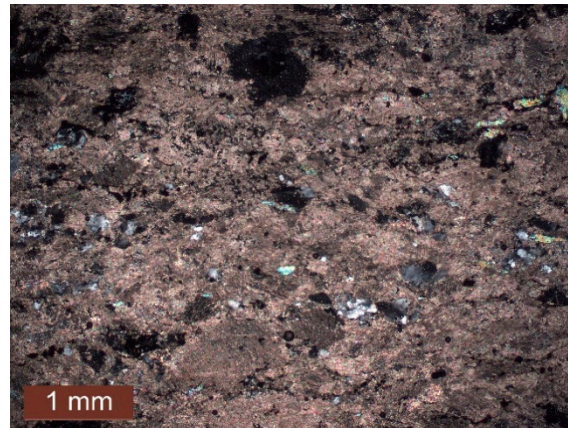
Most of the roofs of the monastery's buildings were covered with traditionally dark-gray plates/slabs. In the petrographic analysis of sample 3 from the remains of stone slabs taken from the collapsed roof of the Haybarn complex during reconstruction, it was concluded that sample 3 represents a schistose marble containing up to 15% volume of mica.

represented by mica and clay. During metamorphism, there was a growth of mica, which together with the recrystallized carbonate defined the schistose structure of the rock (Figure 7). Therefore, by the point of view of textural characteristics, the rock looks like half schistose marble, and half mica schist.

Figure 7. The photomicrograph structure of sample 3 rock, schistose marble.

During the restoration of the Haybarn Complex, carried out in 2005 and 2006, the old stone covering, made of laminated marble that contained much of mica, was used, and the damaged tiles were replaced with new, stone tiles of the same sizes. The alternate pattern was applied for the installation of an old and new roofing, in order to achieve the visual harmony of the roof plane.
