Article

# Restoration of a Historic Building in Order to Improve Energy Efficiency and Energy Saving—Case Study—The Dining Room within the Žiča Monastery Property

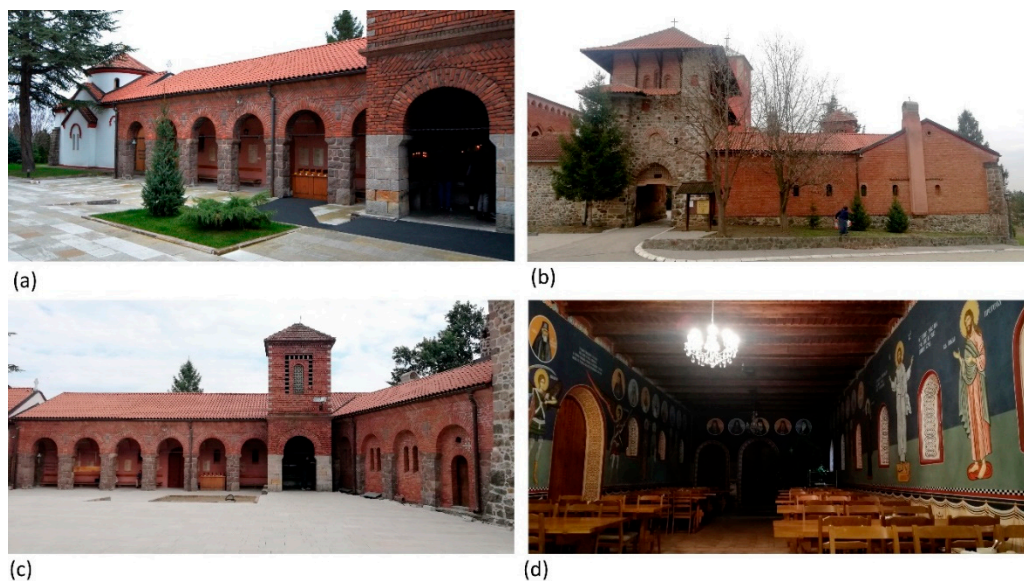
**Figure 1.** The Dining Room of the Žiča Monastery property: (a) appearance of the church of St. Sava and the Dining Room from monastery yard, (b) external appearance of the Dining Room and entrance of the monastery property, (c) appearance of the Dining Room from the monastery yard, (d) the interior of the Dining Room (provided photos taken by the author).

The on-sight analysis showed the condition of the mentioned Church of St. Sava and the Dining Room. The current condition of the Dining Room was the first model in the research—M01. The Church of St. Sava was made of bricks with mortar. Its southern wall rests on the perimeter, supporting the stone wall of the monastery property (Figure 1b). In the spring of 2019, during the first in situ analysis, cracks were detected in the walls and vaults of the Church of St. Sava and on the Dining Room building. Structural dampness was also detected in terms of capillary moisture, visible on the lower part of the perimeter walls of both the church and the Dining Room. All these perimeter walls of the Church and the Dining Room are plastered and frescoed on the inside (M01) (Figure 1d). The façade longitudinal wall of the Dining Room, made of façade brick, was erected, like the wall of the church, on the perimeter, supporting the stone wall of the monastery property. On this facade wall of the Dining Room, there are window openings overlooking the surroundings of the monastery property. The Dining Room has its own porch along the entire length of the building facing the monastery yard (Figure 1c). The constructive assembly of the Dining Room consists of longitudinal bearing walls made of bricks and colonnades with columns made of roughly carved squares of gray sandstone (Figure 1c). Brick vaults were made on the porch between the longitudinal wall and the arched structure with columns. Only the façade wall under the porch is plastered and painted (M01). All other perimeter façade walls of the building are made of façade bricks. In continuation of the Dining Room, on the east side, there are three wooden double doors that connect this space to the closed lobby, to which the Church of St. Sava continues. The façade wall of the Dining Room, in the part where the ancillary rooms and the office are located, and towards the monastery yard—the Porte, is also made of brick façade and has sandstone pilasters, which carry an arched brick façade in the upper zone (Figure 1a,c).

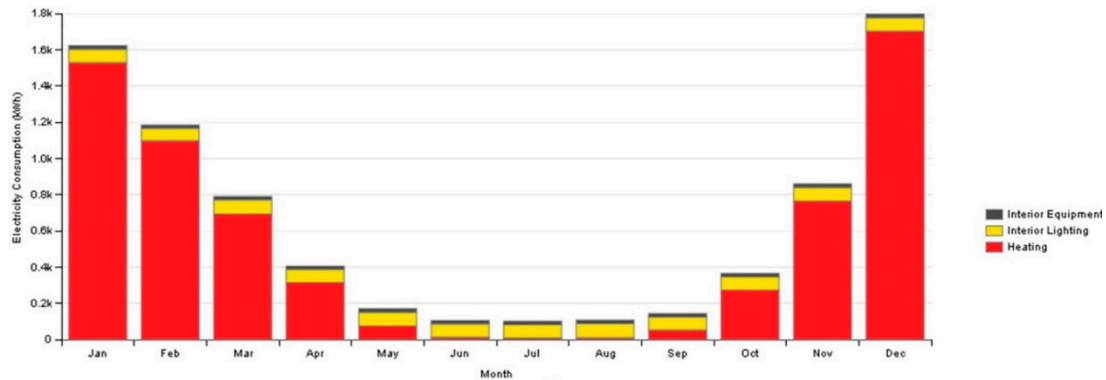
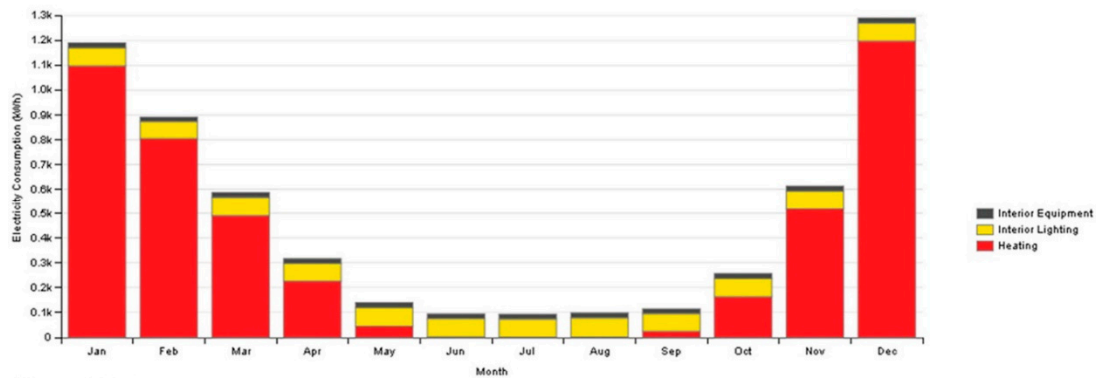
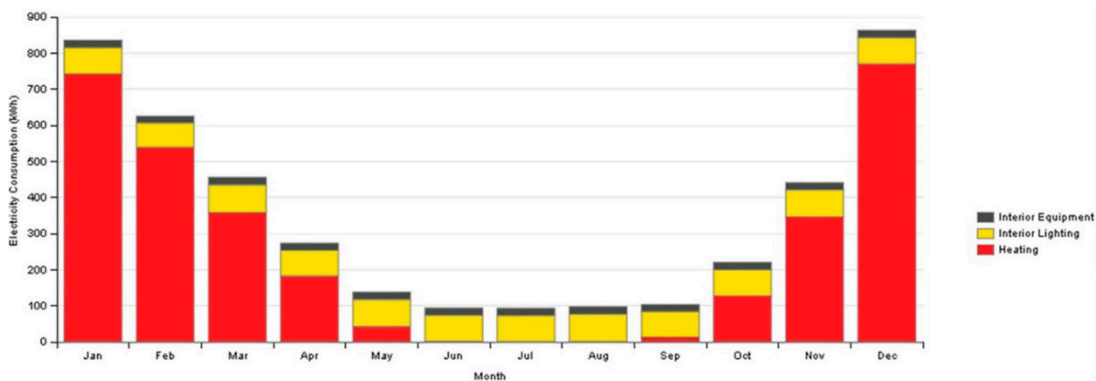
(a) Model M01

(b) Model M02

(c) Model M03

Figure 3. Monthly energy consumption of the models. (a). Model M01; (b). Model M02; (c). Model M03.

The energy performance of the three models throughout the year is shown in Figure 3. The peak heating demand was in the December–January period, having the lowest demand in May and September. In the peak demand period, in December, the Model M01 had a heating energy demand of approximately 1700 kWh, the Model M02 had 1200 kWh which was a 29.4% decrease compared to Model M01, while the Model M03 had a heating energy demand slightly above 750 kWh, which was approximately 55.8% less than the baseline Model M01 and 37.5% less compared to Model M02 for the same period.

From the three models, it is evident that as the heating energy decreased in Model M03, the interior lighting energy had a larger share in the overall energy demand of the building, despite being the same in all of the three models.

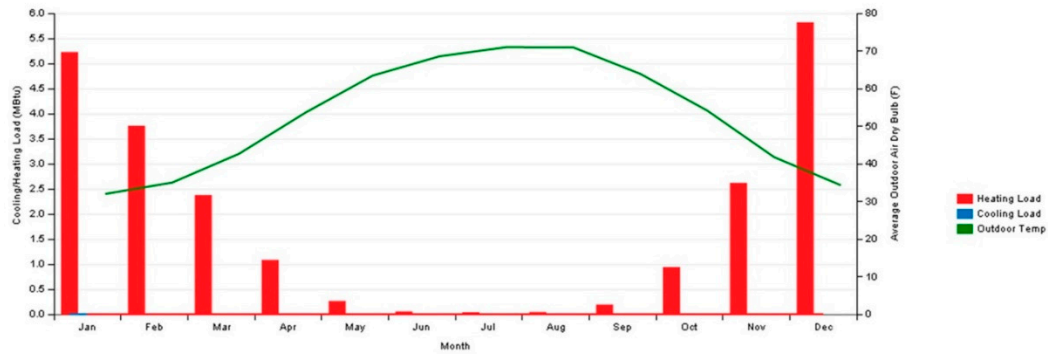
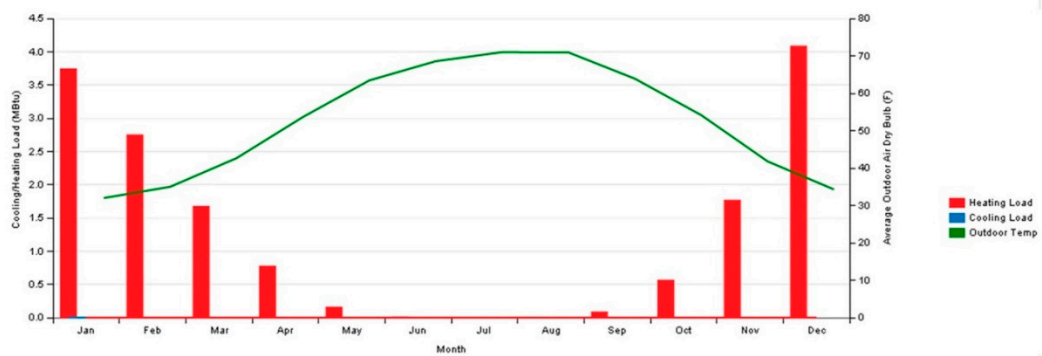
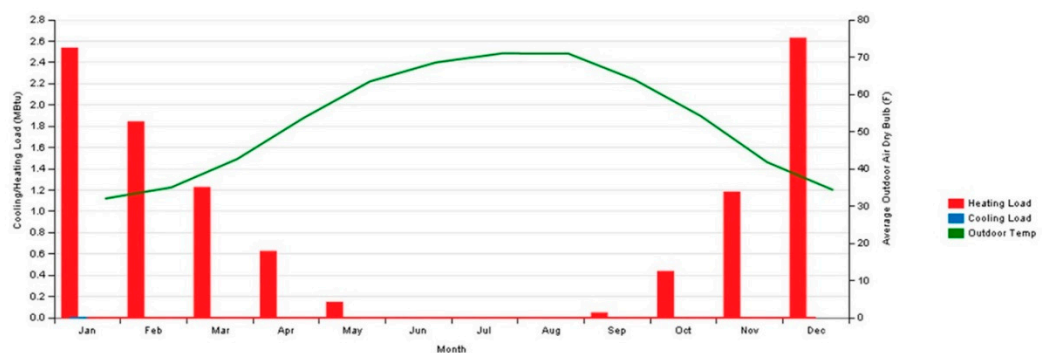
(a) Model M01

(b) Model M02

(c) Model M03

**Figure 4.** Monthly load profiles. (a). Model M01; (b). Model M02; (c). Model M03.

The monthly heating loads in relation to the outdoor temperature variation are shown in Figure 4. It is evident that the heating load in Model M03 was almost twice as low as Model M01 in December and January.

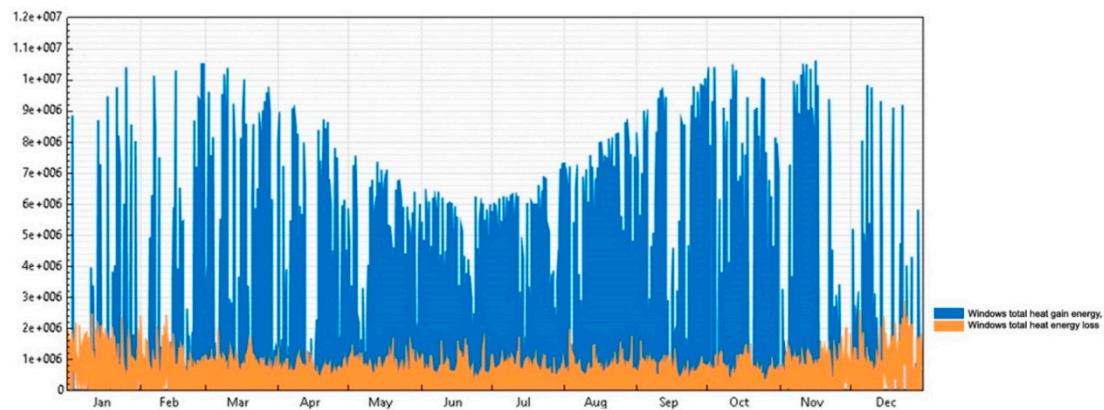
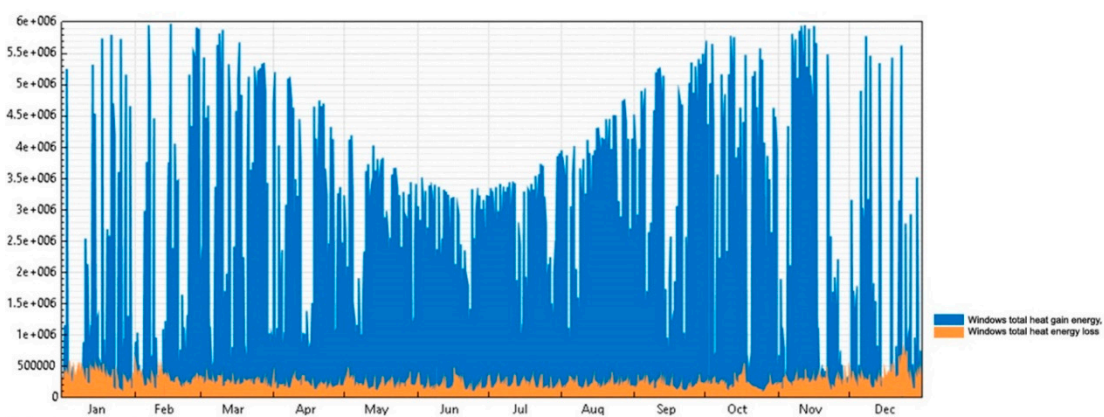
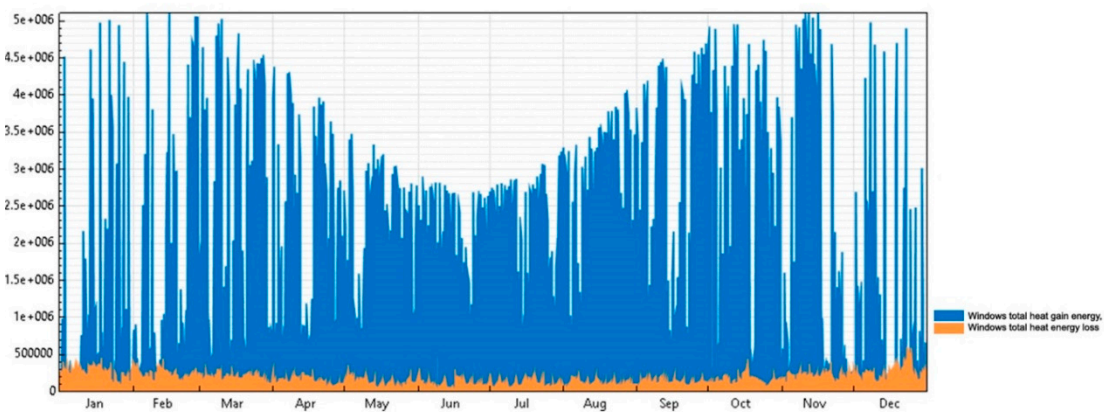
(a) Model M01

(b) Model M02

(c) Model M03

**Figure 5.** Windows heat gain and loss energy. (a). Model M01; (b). Model M02; (c). Model M03.

The influence of the windows on the energy performance of the analyzed models is shown in Figure 5. The solar heat gains and losses were the highest in Model M01 and the lowest in the Model M03, showing the superior energy efficiency performance of the windows used in the latter model. The losses in Model M03 were more than twice as low as the losses in Model M01.

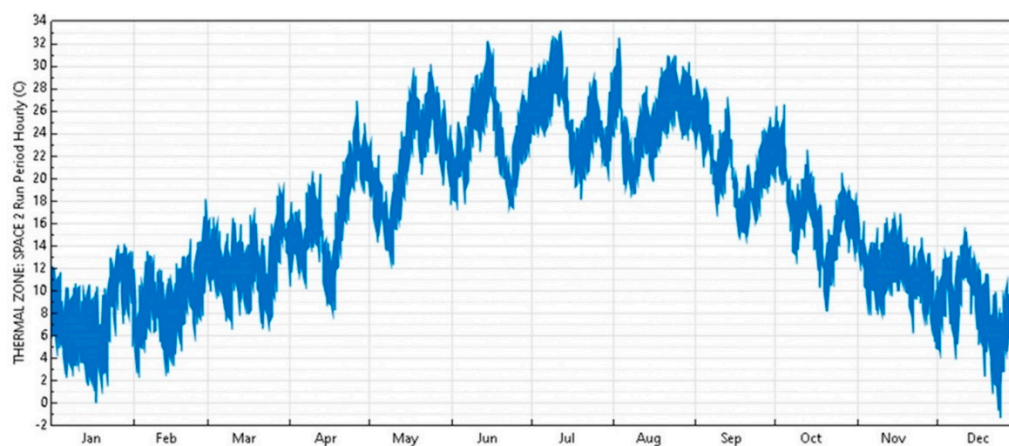
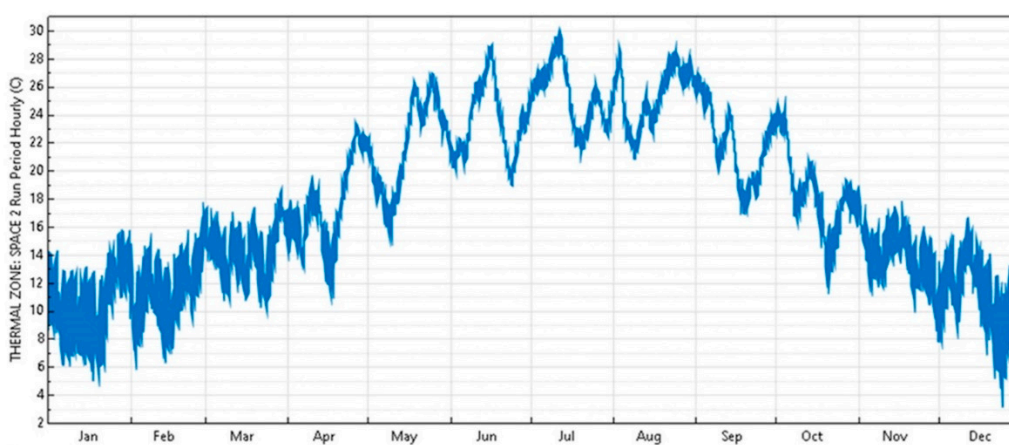
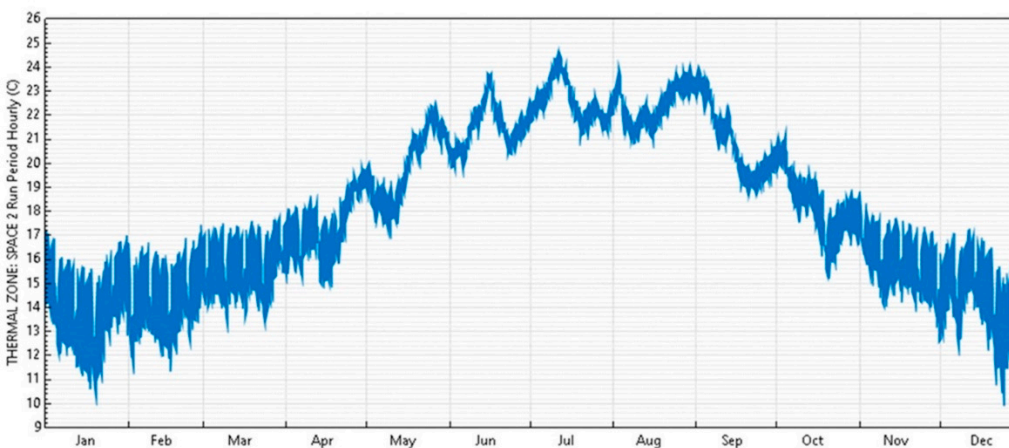
(a) Model M01

(b) Model M02

(c) Model M03

**Figure 6.** Mean radiant temperature. (a). Model M01; (b). Model M02; (c). Model M03.

The interior comfort of the Dining Room building was analyzed in terms of mean radiant temperature, as shown in Figure 6. It can be noted that the temperature variations in Model M01 in each month throughout the year were higher than the other two models. The Model M03 had the lowest temperature variations, where in the winter the lowest temperature was 10 °C, and in the summer the peak was 24 °C, due to the low U-values of its building envelope. For comparison, the minimum and the maximum temperatures in Model M01 were 0–32 °C, while in Model M02, they were 5–32 °C.

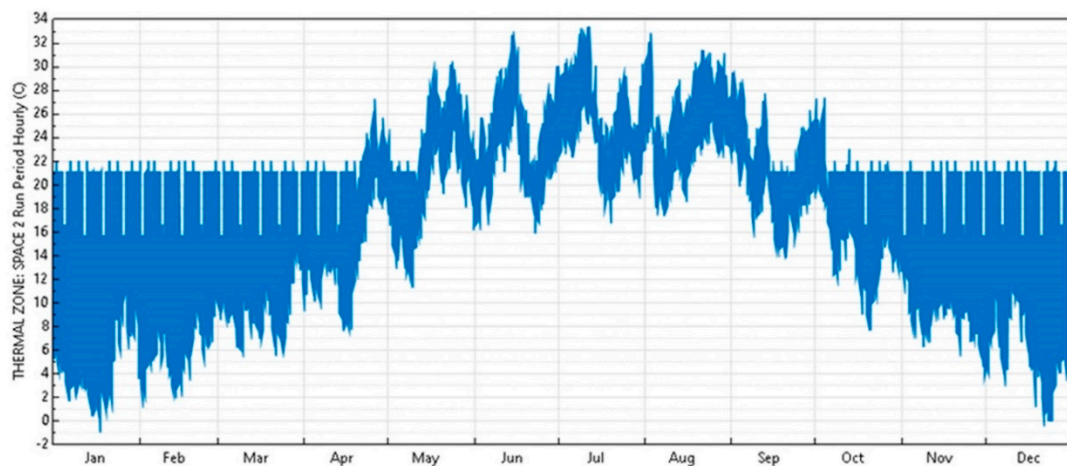
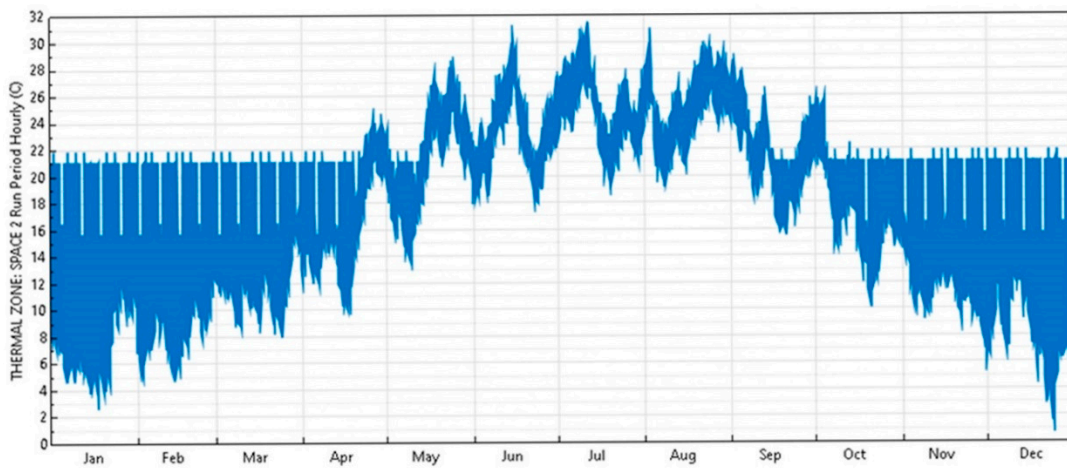
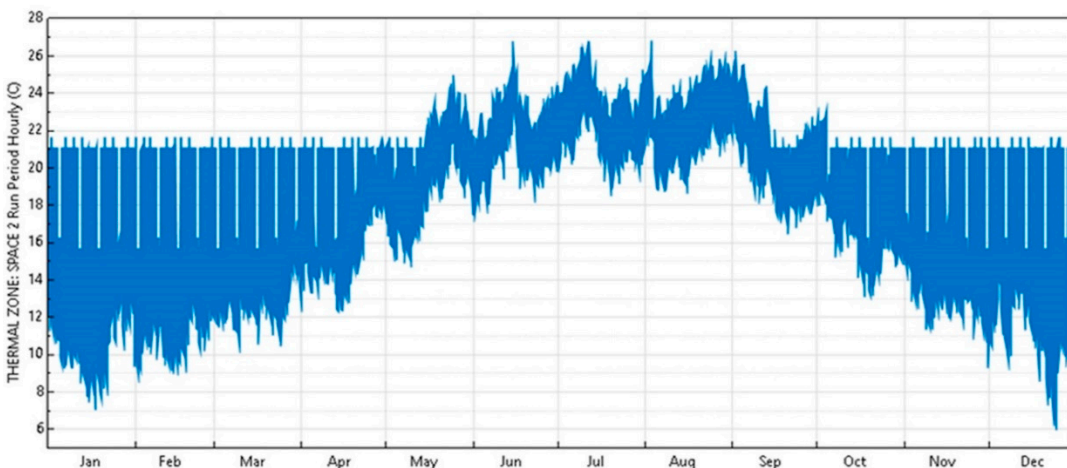
(a) Model M01

(b) Model M02

(c) Model M03

**Figure 7.** Mean air temperature. (a). Model M01; (b). Model M02; (c). Model M03.

Furthermore, the air temperature analysis of the three models is shown in Figure 7. The poor thermal characteristics of the building envelope of Model M01 forced the heating system to work harder and spend more energy in the heating season, considering that it had to start from the lowest temperature of 0 °C in December–January and to achieve a relatively comfortable air temperature of 21 °C. The lowest air temperature in Model M02, for the same period of December–January, was slightly higher amounting to 3 °C, whereas in the Model M03, it was significantly higher, amounting to 7 °C, thus decreasing the starting point of the heating system and leading to lower heating energy consumption for achieving an interior air temperature of 21 °C.
