## INVESTIGATION OF LATE ANTIQUE BRICKS FROM ARCHAEOLOGICAL SITES OF CONTEMPORARY SERBIA AS A BASIS OF CONSERVATION WORKS

**Ana Radivojević**

University of Belgrade, Faculty of Architecture, 11000 Belgrade, Serbia and Montenegro

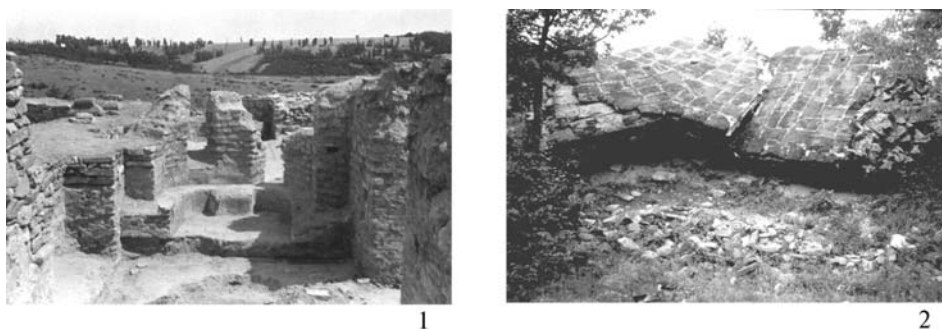
Fig. 1. Condition of the site of Bregovina in the time of conducted conservation works (1) and today (2)

One may find the extreme example in the case of Bregovina. The site represents the VI century fortification, within which there was a basilica. The well-preserved remains of the building were discovered and properly conserved in early 1960's. However, left without the public affirmation, being far away from the main roads and in an environment where local people, instead of protecting their heritage, used these ruins as a storage of building materials, the site was doomed to its almost complete disappearance today (Figure 1).

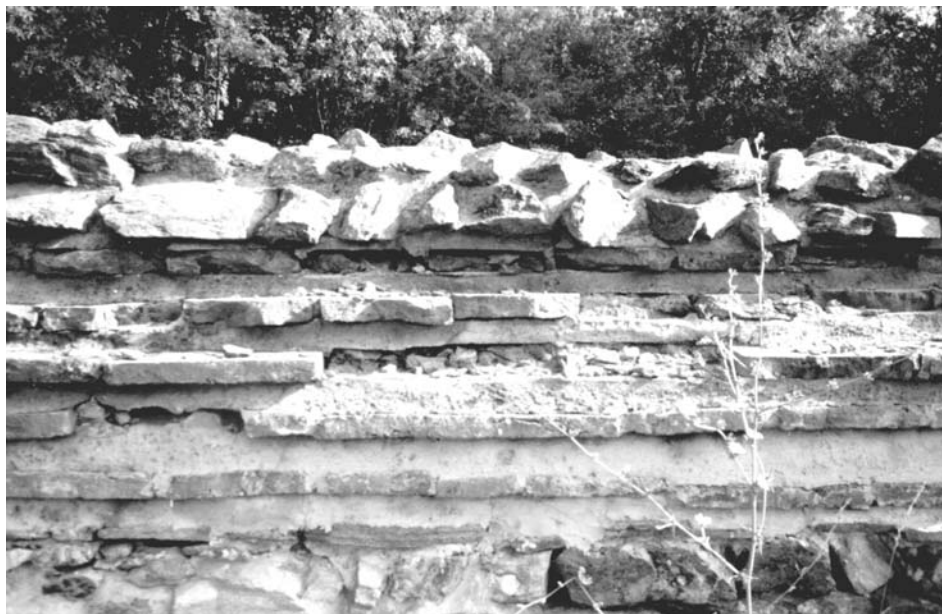
Fig. 2. Typical example of degradation - part of wall of a so-called double basilica from the archaeological site of Caričin Grad, extended with contemporary materials

In respect to this, in the case of the analyzed late antique sites the applied conservation practice experienced different problems. The question of a quality of contact is, in case of the original parts, a matter of degree of their decay. Consequently, in the firm parts of the original structure, which did not suffer from any decay, the bond is, in most of the cases, strong. However, the application of new materials, especially the application of a new mortar, could cause a weak bond between the brickwork parts, e.g. mortar and brick (either original or new one). Furthermore, we could say that in certain cases a different type of salt crystallization appeared on new materials, especially on the new bricks for repair work (Figure 2). This could be explained by their incompatibility regarding the chemical contents. But even when the new brick did not have any problems with salts, its durability proved to be lower in comparison with the original bricks.

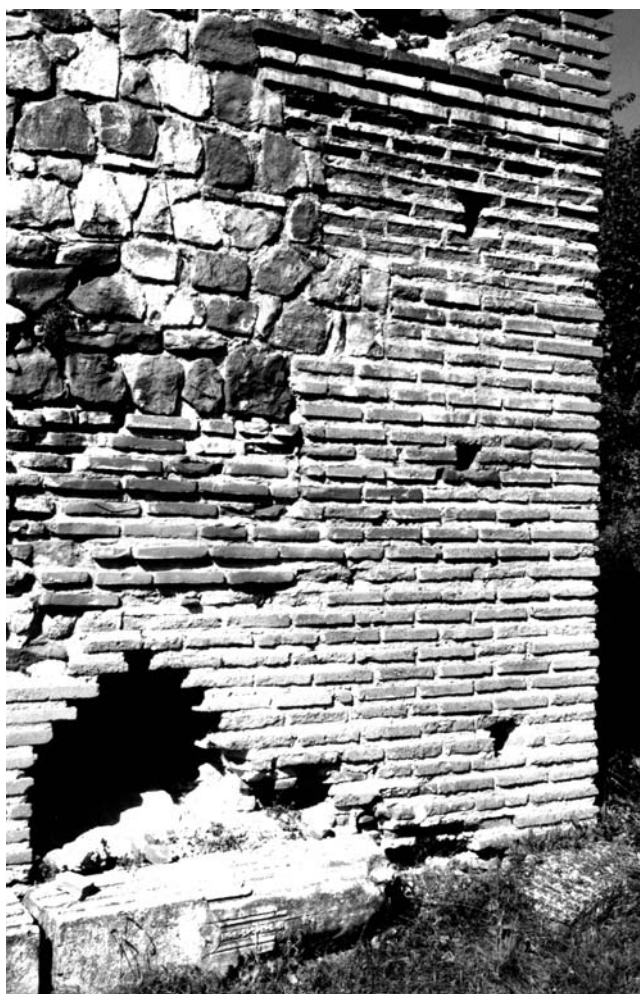
Fig. 3. Detail from the fortification of Gamzigrad (Felix Romuliana) where bricks produced in a different way were applied in different phases of conservation work

bricks were produced ranged from the traditional brick manufactory, to the contemporary brick production that relies on the use of the semi-dry pressing procedure, or even to inventing the completely new, so called "concrete bricks" (Figure 3). These bricks were used in some cases as a replacement for the original clay material.
